# Jocko River Master Plan

## Appendix C: Demonstration Reach Phase I Monitoring Plan

# **JOCKO RIVER DEMONSTRATION REACH PHASE I**

## **Monitoring Plan and Annual Reporting 2006**

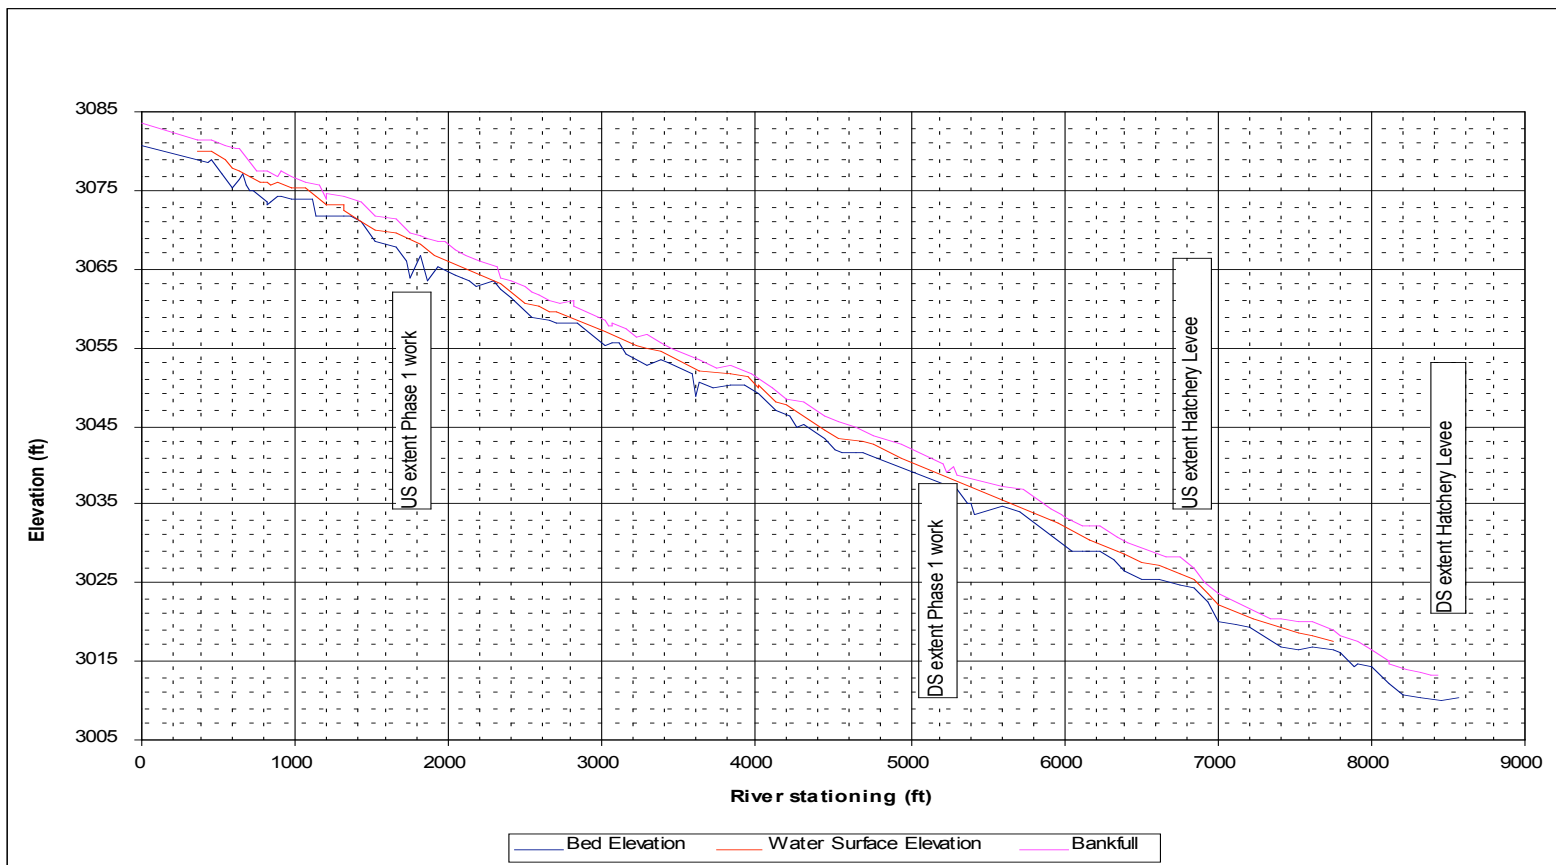
**Figure 1.** Baseline, pre-construction monitoring long profile survey of Demonstration Reach Phases I and II

Figure 1 shows the results of the long profile survey through the Demonstration Reach conducted for baseline monitoring prior to construction of the project. This profile includes both Phase I and future phases of the Demonstration Reach. The lack of pools is apparent on this profile. Figure 2 is a longitudinal profile through the reach surveyed during implementation monitoring to document as-built conditions. This profile shows bed and water surface elevations, bankfull elevations, and select design elevations to compare with as-built conditions. The overall slope is 0.008 ft/ft, similar to the pre-

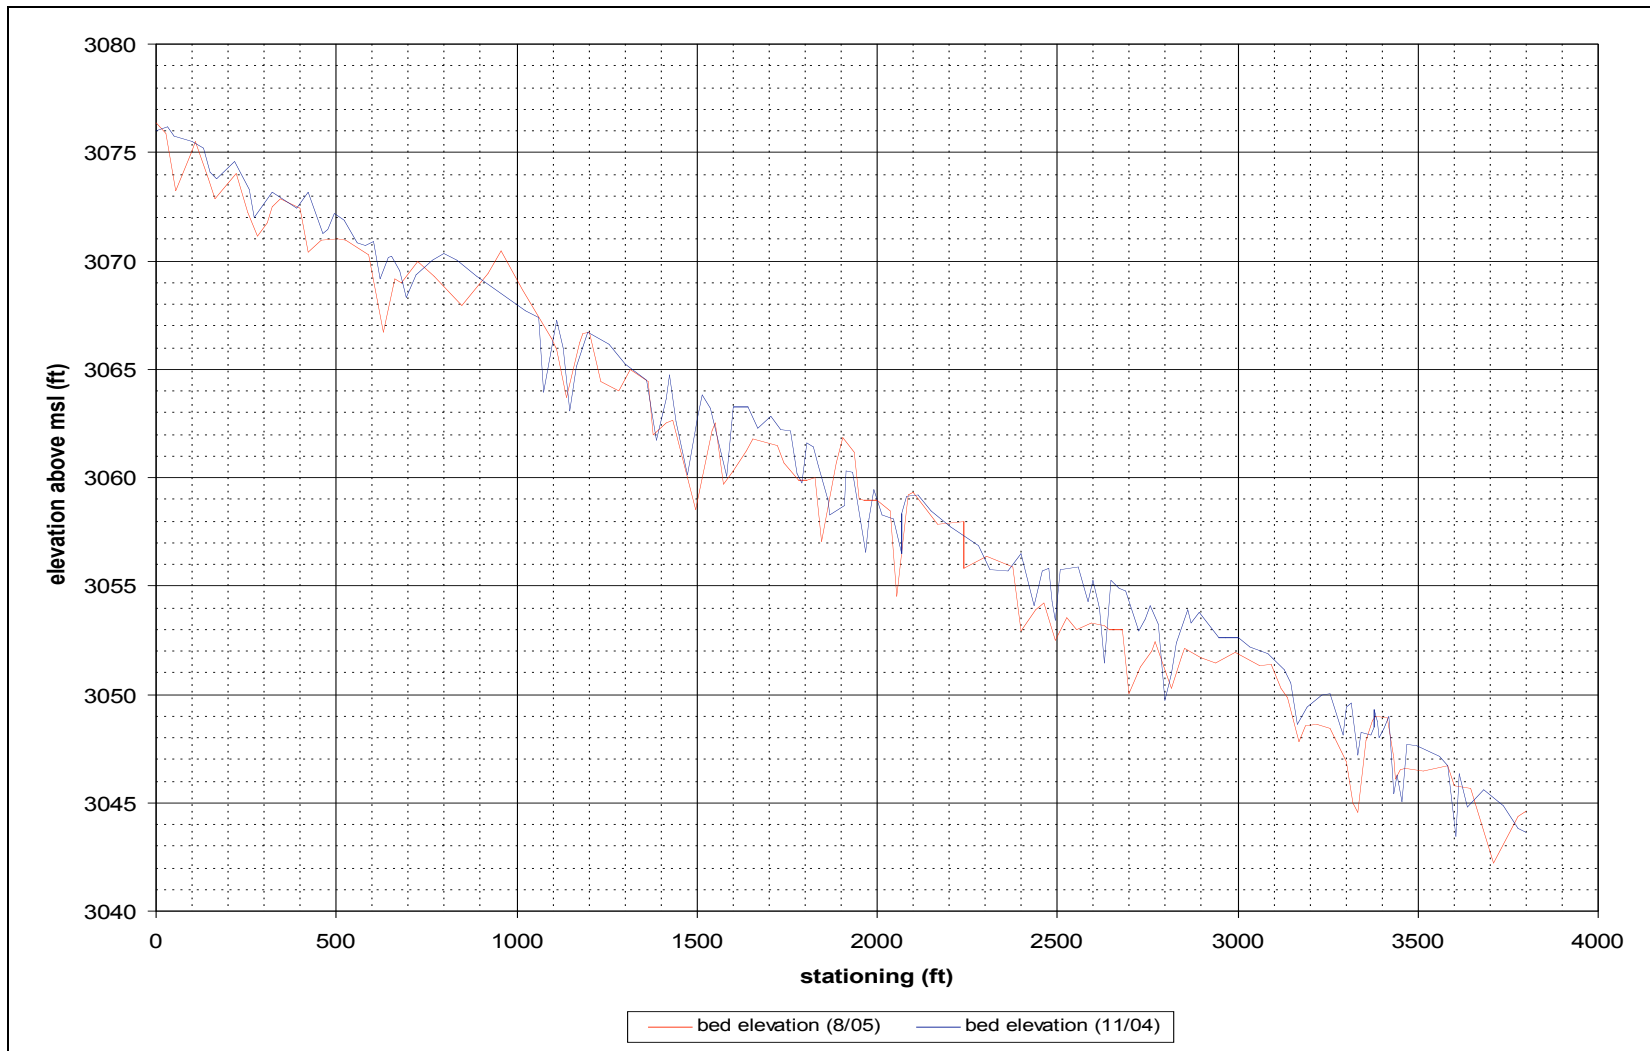
**Figure 3.** Implementation (blue line) and 2005 effectiveness monitoring (red line) longitudinal profile for Demonstration Reach Phase I

Figure 3 shows the results of the long profile survey through the Demonstration Reach conducted in 2004 for implementation monitoring (Figure 2) overlaid with the long profile survey conducted in 2005 for effectiveness monitoring. In June 2005, prior collection of 2005 effectiveness monitoring data, a flood with a recurrence interval exceeding a 20 year event, occurred in the Jocko River. The effects of this event is partially evident in Figure 3 and include (1) bed mobilization where an armour layer had not re-formed, (2) scour and loss of designed cobble tailouts leading to bed degradation and some scour below vane logs, (3) re-sorting of bed material leading to transient aggradation in pool features, deepening in some pool features, and (4) steepening of the design slope for many of the constructed point bars. In four locations, minor work was completed following the effectiveness monitoring event to improve structure stability.

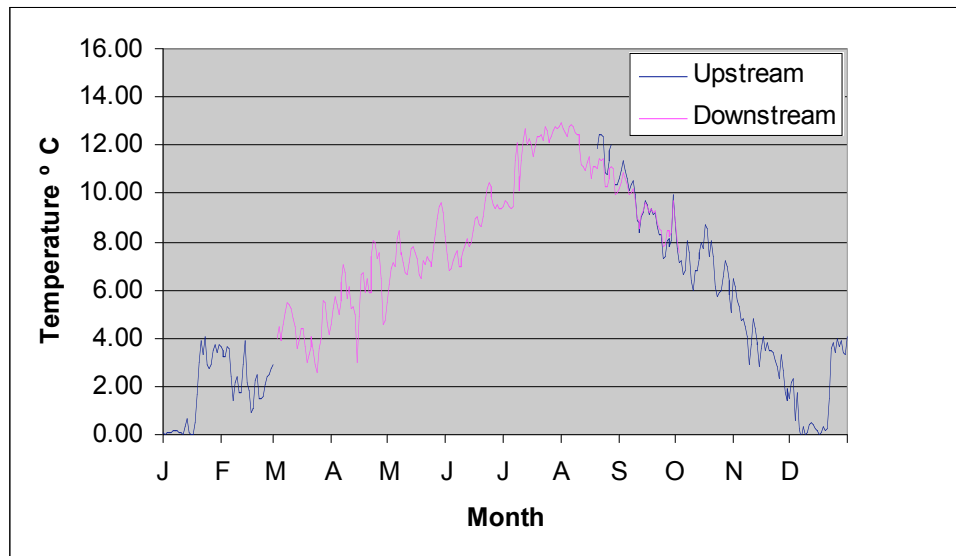
**Figure 15.** Mean daily water temperatures at monitoring locations immediately upstream and downstream of the Jocko River Demonstration reach near Arlee, Montana during 2005. Note missing data resulting from the loss and failure of thermographs during the monitoring period.

We monitored temperatures through 2005, but comparisons with earlier data are complicated by the loss or failure of three different thermographs, resulting in missing data through much of 2005, particularly when we might anticipate temperature divergence between upper and lower sites from groundwater inputs (Figure 15). Thus, any inferences from effectiveness monitoring of temperatures during 2005 are generally equivocal. However, additional temperature and hydrology data collected during groundwater studies may supplement surface water temperature monitoring and more thoroughly answer questions about surface water-groundwater interactions before and after restoration.

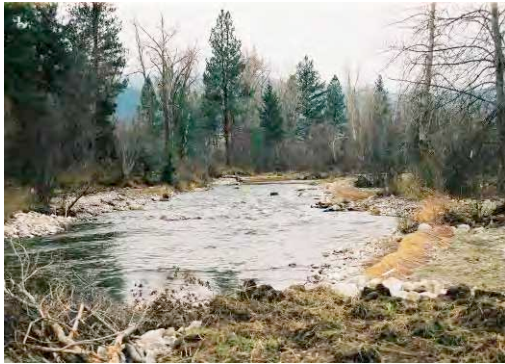
Photo was taken from right bank at Station 84+00 looking WSW (247.5°). The existing green line is located approximately 10 feet from bankfull and consists of knapweed, shrubs and cottonwood. Vegetation width is approximately 50 feet. Beyond this is bare floodplain area created during fill of the abandoned channel. Channel banks treated with bioengineered soil lifts and coir fascines incorporating willow cuttings. Native shrubs, trees herbaceous species were planted, transplanted, sodded and seeded in this area. Green line along left bank is located approximately 10 feet above bankfull (below this is cobble placed to create the new channel). Green line is approx. 15 feet wide and consists of reed canarygrass, knapweed, red top and scattered shrubs (alder). Community type transitions to pine with shrub and herbaceous understory.

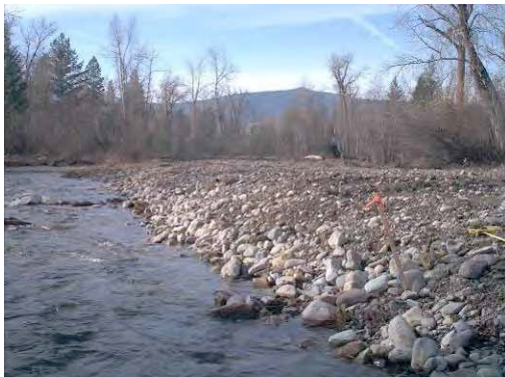
Photo was taken from right bank at Station 81+75 looking WSW (247.5°). The existing green line is located approximately 75 feet from the new right bank and consists of predominantly cottonwood with a shrub understory (approx. 50 feet wide). Community type transitions to cottonwood, pines, and shrub vegetation beyond this. Newly constructed floodplain was seeded and planted with native shrubs, trees and herbaceous wetland plants.

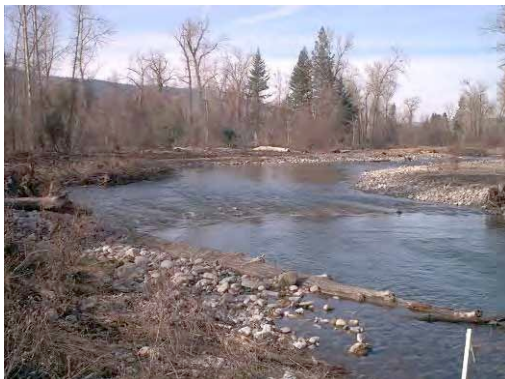
Photo was taken from left bank at Station 80+00 looking NW (315°). The existing green line is located at bankfull and consists of predominantly knapweed (approx. 10 feet wide). Community type transitions to cottonwood, pines, and shrub riparian vegetation beyond this. No vegetation treatments were implemented in this area along the new channel. Area will be monitored to see if raised channel will reduce knapweed along the channel.

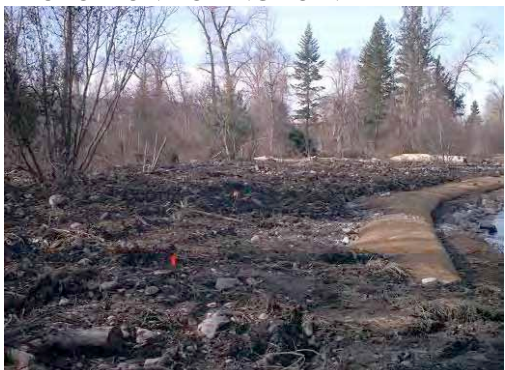
Photo was taken from left bank at Station 79+00 looking NW (315°). The existing green line is located approximately 50 feet from the newly constructed left bank and consists of predominantly reed cottonwood, upland shrubs, and knapweed (approx. 50 feet wide). Community type transitions to cottonwood, wetland shrubs and herbaceous wetland species. The newly constructed floodplain was planted and seeded with native trees, shrubs, and herbaceous wetland plants.

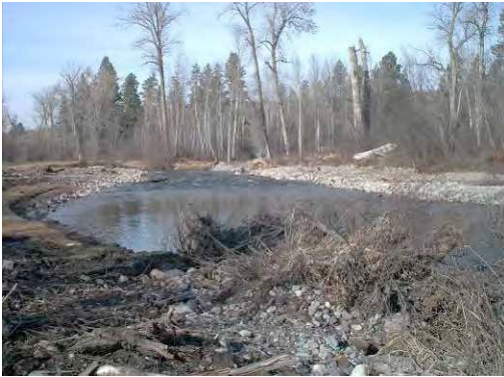
Photo was taken from left bank at Station 79+00 looking NNW (337.5°). Existing green line for left bank is described in Photo 8. The existing green line for the right bank is located approximately 15 feet above bankfull and consists of predominantly cottonwoods, upland shrub understory and knapweed. Herbaceous wetland plugs were planted along the channel.

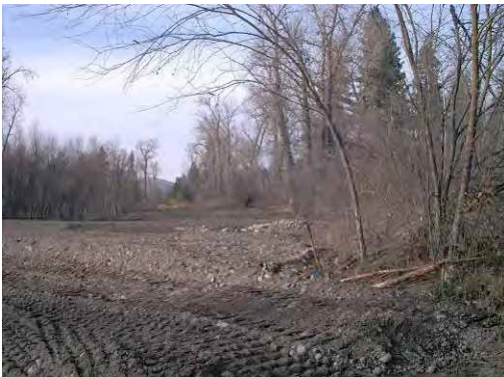
Photo was taken from right bank at Station 76+50 looking NW (315°). Photo is of abandoned channel area filled to create wetlands. The existing green line along the right side of the filled channel consists of predominantly shrubs (alder) for 20 feet and transitions to pines and upland shrubs and herbaceous species. The existing green line along the left side of the filled channel consists of cottonwoods, upland and wetland shrubs and upland herbaceous species (100 feet) and community type transitions to wetland shrubs with a wetland herbaceous species understory. Area was seeded and planted with native shrubs, trees and wetland herbaceous species.

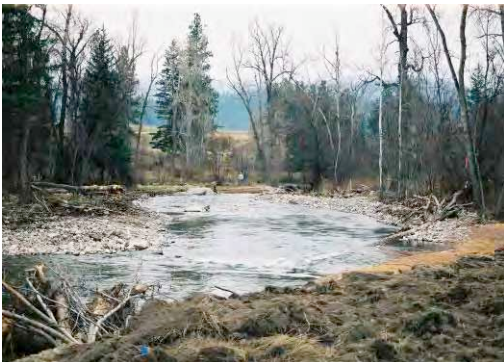
Photo was taken from right bank at Station 76+50 looking WSW (247.5°). The existing green line for both left and right banks is located approximately 10 feet above bankfull and consists of cottonwoods, pines and wetland and upland shrubs and herbaceous understory. Newly created channel banks were seeded and planted with native trees, shrubs and herbaceous wetland species.

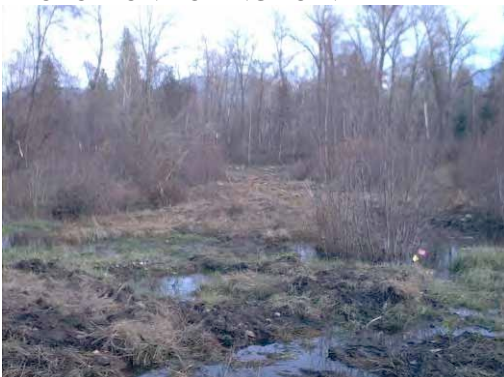
Photo was taken from left bank at Station 73+00 looking SE (135°). Photo is of plugged side channel area. The existing green line is located at bankfull and consists of transplanted wetland sod and shrubs. Area was seeded and planted with herbaceous wetland plugs, planted with transplanted wetland shrubs and wetland sod.

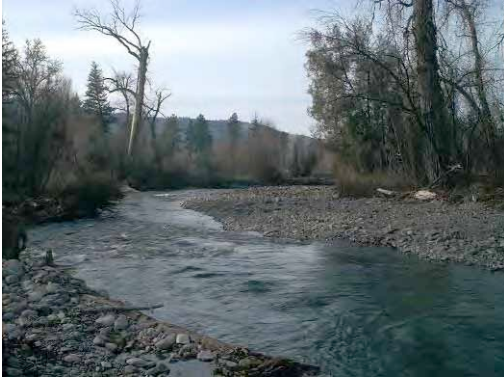
Photo was taken from left bank at Station 72+00 looking NW (315°). The existing green line on the right bank is located approximately 10 feet above bankfull and consists of predominantly cottonwoods with an understory of wetland shrubs and herbaceous vegetation. The existing green line on the left bank is located at bankfull and consists of existing vegetation including wetland shrubs and herbaceous vegetation and knapweed. Newly created banks were planted with herbaceous plugs and seeded.

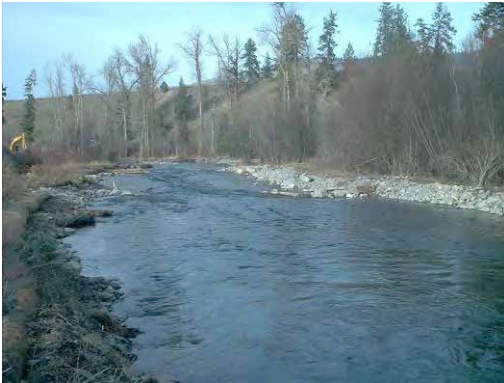
Photo was taken from left bank at Station 69+75 looking N (0°). The existing green line on the right bank is located approximately 2 feet above bankfull and consists of wetland shrubs and wetland herbaceous species. The existing green line on the left bank is located approximately 5 feet above bankfull and consists of wetland and upland shrubs and wetland and upland herbaceous species and knapweed. Vegetation treatments include seeding and planting of wetland herbaceous species and soil bioengineering incorporating willow cuttings.

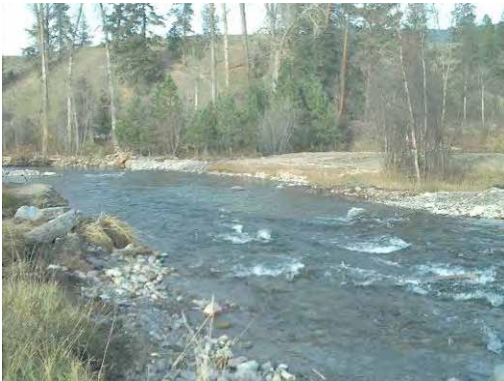
Photo was taken from left bank at Station 68+00 looking NNE (22.5°). The existing green line along the right bank is located at bankfull and consists of wetland shrubs and wetland herbaceous species. The existing green line along the left bank is located approximately 5 feet above bankfull and consists of wetland and upland shrubs and wetland and herbaceous species for approximately 50 feet. Community type transitions to floodplain dominated by upland herbaceous species and knapweed with scattered upland shrubs. Vegetation treatments include seeding and planting of wetland herbaceous species.

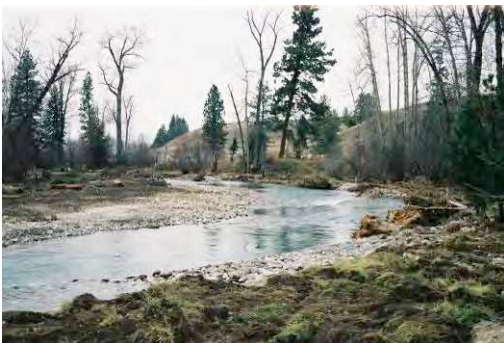
Photo was taken from right bank at Station 67+00 looking NW (315°). The existing green line along the right bank consists of transplanted sod placed at downstream end of wetland plug and transitions to pine, cottonwood and wetland and upland shrubs. Green line along the left bank is approximately 50 feet from the edge of the newly constructed channel and consists of pines, cottonwood, upland shrubs and herbaceous species and knapweed for approx. 50 feet and then transitions to open floodplain dominated by upland herbaceous species and knapweed. No planting or seeding was done in Fall 2004.

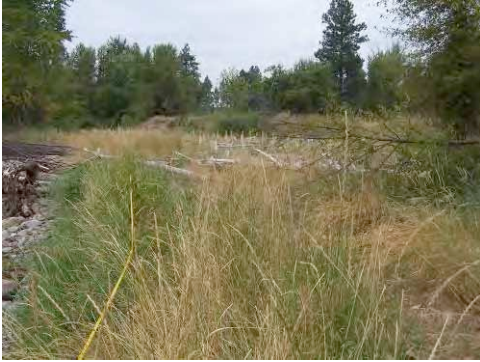
Photo was taken from right bank looking NNW (337.5°). Photo corresponds with Photo Monitoring Point 4-2004. Photo is looking into abandoned channel area filled with cobble and top soil and planted with containerized shrubs during Fall 2004. Soil lift 1 is located in the bottom left of the photo. Grasses are from seeding done during construction of the lift. Green line is at approximately bankfull and consists of seeded native grasses and recruited native forbs. Knapweed was present in small amounts.

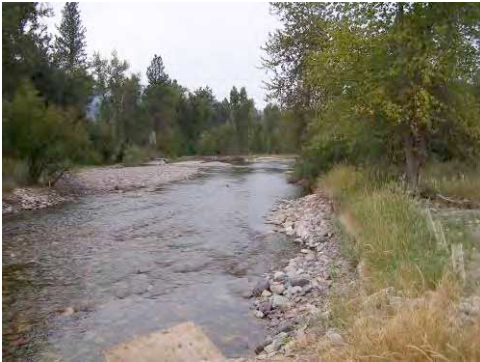
Photo was taken from right bank looking W. Photo corresponds approximately with Photo Monitoring Point 5-2004. Right bank green line is at bankfull and consists of grasses from bare surfaces soil lift during construction. Soil lift 2 is located in lower right corner of photo. Left bank green line is at bankfull and consists of native riparian shrubs such as alder and dogwood. Community type transitions to cottonwood, pines, and drier shrub vegetation beyond this. Newly constructed floodplain was seeded and planted with native shrubs, trees and herbaceous wetland plants.

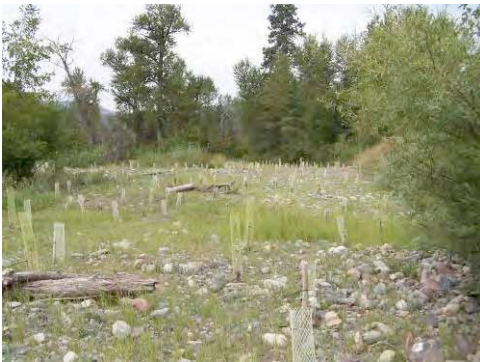
Photo was taken from left bank at same location as Photo Monitoring Point 6-2005 looking NNW (337.5°). Photo point does not correspond with 2004 monitoring point. Photo is looking into filled channel area that was seeded and planted with containerized native shrubs, trees and herbaceous species. Existing vegetation on photo right is reed canarygrass and sandbar willow. Existing vegetation on photo left is cottonwood, alder and birch. Some knapweed is present.

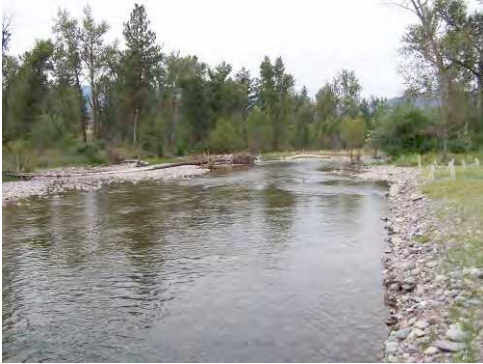
Photo was taken from right bank looking W. Corresponds approximately with Photo Monitoring Point 6-2004. Photo looking downstream towards section of channel that widened and braided during the spring 2005 flood. Right bank green line is located at bankfull and consists of seeded grasses. Native shrubs and herbaceous species planted in constructed floodplain.

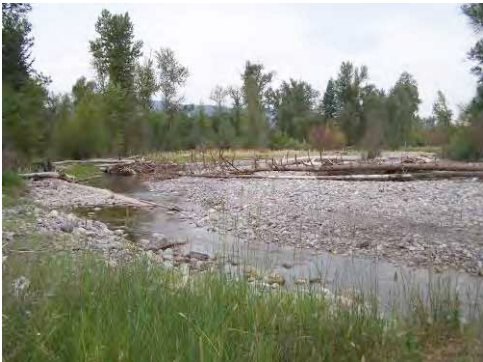
Photo was taken from left bank looking NW (315°). Photo shows a section of the channel that braided during spring 2005 flood event. Existing green line on left bank consists of knapweed and timothy at bankfull and transitions to cottonwood and pine with understory of dry shrubs and grasses. This photo point was not recorded in 2004. Photo was taken to document changes in channel as a result of the 2005 flood event and prior to repairing channel structures that were damaged during the flood.

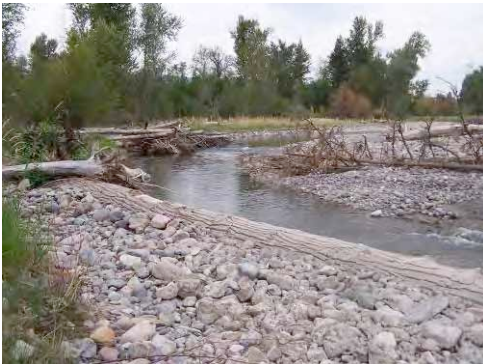
Photo was taken from left bank at looking NNW (337.5°). Photo corresponds with Photo Monitoring Point 7-2004. Cobble accumulation behind vane arm at bottom of photo is a result of the spring 2005 flood event. Pine on bar is also recruited from flood event. Left bank green line is located approximately 1 foot above bankfull and consists of knapweed and grasses. Green line transitions to cottonwood and pine with understory of dry shrubs and grasses. Transplanted shrubs around structure are alive and consist of alder and birch. Salvaged shrubs also located at soil lift 3, which is located on photo left center. In general, smaller shrubs had more new growth.

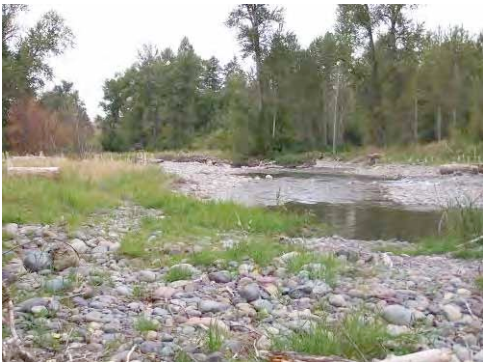
Photo was taken from left bank looking NW (315°). Photo corresponds approximately with Photo Monitoring Point 9-2004. The left bank green line is located at bankfull and consists of seeded grasses and planted shrubs, trees and herbaceous species. Vegetation is described more in Photo Monitoring Point 12-2005 notes. The existing green line for the right bank is located approximately 15 feet above bankfull and consists of predominantly cottonwoods, upland shrub understory and knapweed. Herbaceous wetland plugs were planted along the channel. No survival plots are located here, but survival appears to be high.

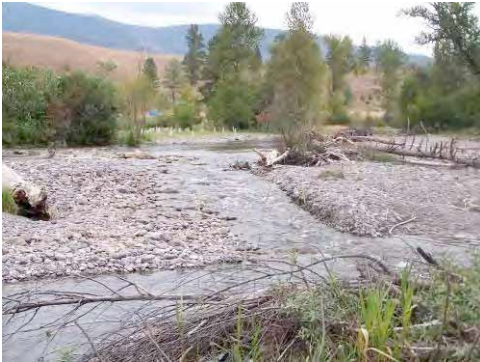
Photo was taken from right bank looking upstream (E) from same spot as Photo Monitoring Point 11-2005. This photo was taken to show how the channel braided during the Spring 2005 flood event.

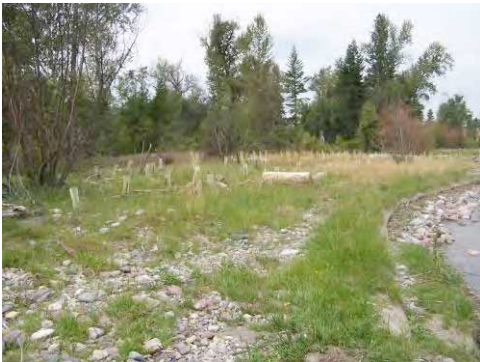
Photo was taken from left bank looking NW (315°). The green line was previously located approximately 50 feet from the newly constructed channel. Community type transitions to cottonwood, wetland shrubs and herbaceous wetland species. Numerous shrubs were transplanted to the constructed floodplain. In general, the smaller shrubs had more new growth compared with the larger shrubs. Birch appeared to have more growth compared with alder. Approximately 50% of transplanted shrubs in this location appeared to be alive. One vegetation survival plot is located in this area. Birch that is at photo right center was formerly located along the channel and was filled around that is dead.

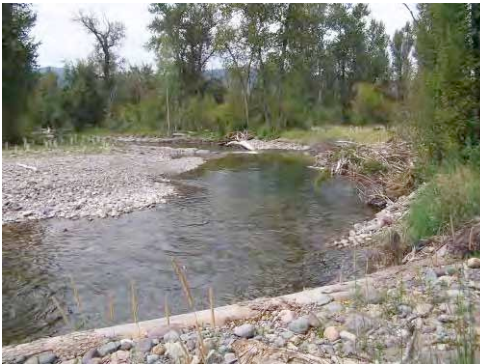
Photo was taken from right bank looking. The existing green line on the right bank is located approximately 2 feet above bankfull and consists of wetland shrubs and wetland herbaceous species. The existing green line on the left bank is located approximately 5 feet above bankfull and consists of wetland and upland shrubs and wetland and upland herbaceous species and knapweed. Vegetation treatments include seeding and planting of wetland herbaceous species and soil bioengineering incorporating willow cuttings.

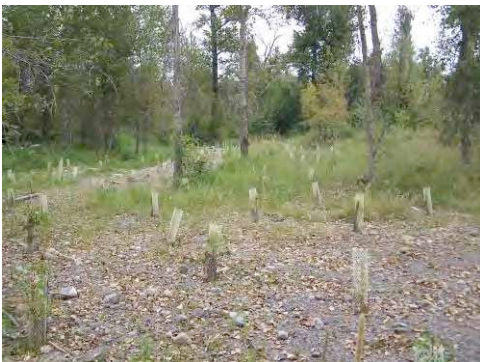
Photo was taken looking NNE (22.5°). Photo is looking into area where clearwater diversion was dug during channel construction. Area was seeded and planted with native shrubs and trees. One vegetation survival plot is located in this area.

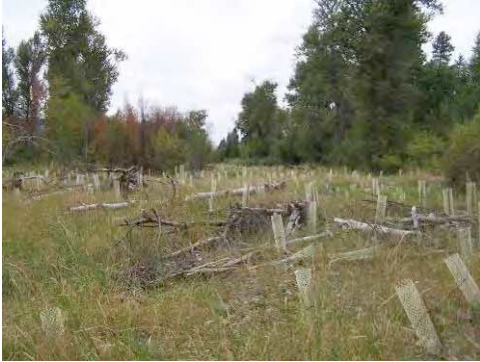
Photo was taken from right bank looking NW (315°). Photo is looking into plugged channel area. Area was seeded and planted with native tree, shrub and herbaceous species. Surface was complete bare post-construction. Two survival plots are located within plugged area. Herbaceous species in photo are a mix of seeded and recruited species including wetland forbs and some knapweed.

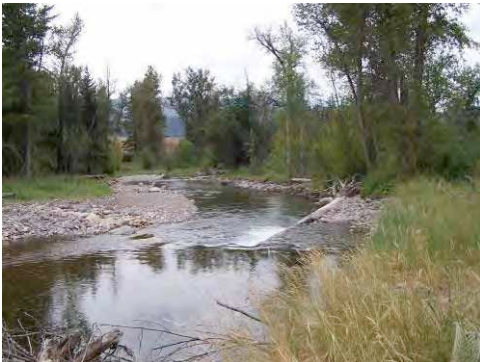
Photo was taken from right bank looking WSW (247.5°). Photo is from same location as Photo Monitoring Point 11-2004. Right bank green line is located at bankfull and consists of seeded grass species. Transitions to cottonwood with a shrub understory along right and left banks at bankfull downstream. Soil lift 7 is located at photo right where grasses are coming in.

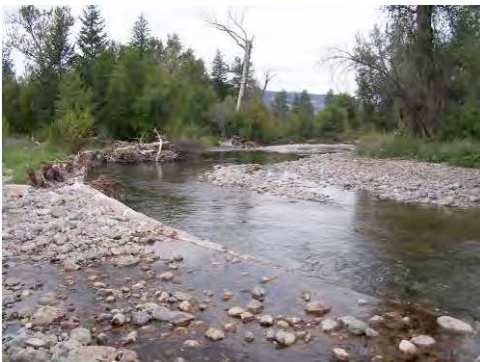
Photo was taken from left bank looking NW (315°). The existing green line on the right bank is located approximately 10 feet above bankfull and consists of predominantly cottonwoods with an understory of wetland shrubs and herbaceous vegetation. The existing green line on the left bank is located at bankfull and consists of existing vegetation including wetland shrubs and herbaceous vegetation and knapweed. Newly created banks were planted with herbaceous plugs and seeded. Most of the planted plugs were lost during the Spring 2005 flood event. Soil lift 8 is located at photo left center.

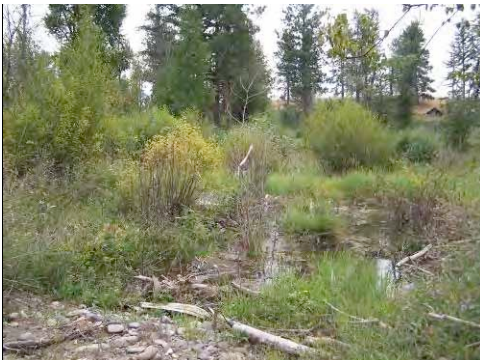
Photo was taken from left bank looking SE (135°). Photo is from same point as Photo Monitoring Point 12-2004. This was a former side channel area that was plugged and a portion of the channel re-aligned through it. Most of the shrubs in the photo were transplanted during construction. Shrub transplant survival appears to be 100% with many having vigorous growth. Area is very wet with diverse wetland species including sedges, rushes and forbs. Lots of fresh sand deposition in this area from spring 2005 flood event.

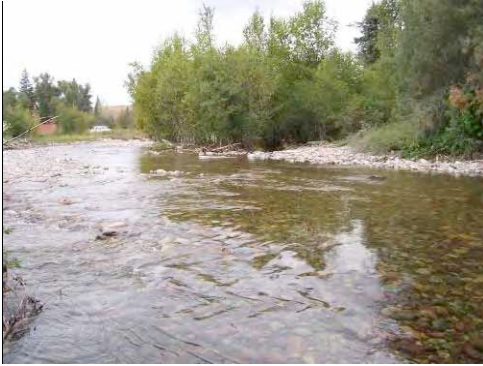
Photo does not correspond with 2004 monitoring point. Photo taken to show changes that occurred to channel during Spring 2005 flood event. Right green line consists of native shrubs including willow, alder and birch at bankfull. Community type transitions to cottonwoods with drier shrub understory. Left green line consists of native shrubs including alder, birch and dogwood at bankfull. Community type transitions to an upland terrace.

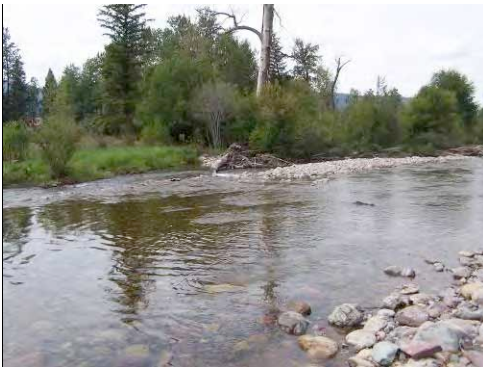
Photo does not correspond with 2004 monitoring point. Photo taken to show changes that occurred to channel during Spring 2005 flood event. Photo shows channel deposition and widening.

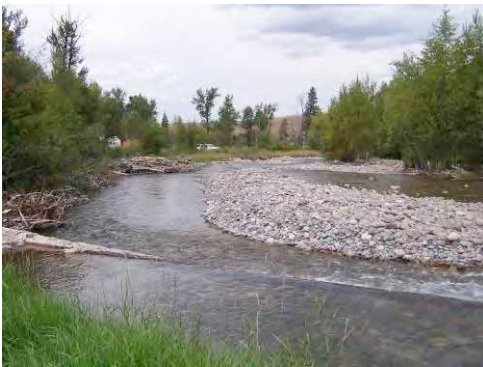
Photo does not correspond with 2004 monitoring point. Photo taken to show changes that occurred to channel during Spring 2005 flood event. Photo shows channel deposition and braiding.

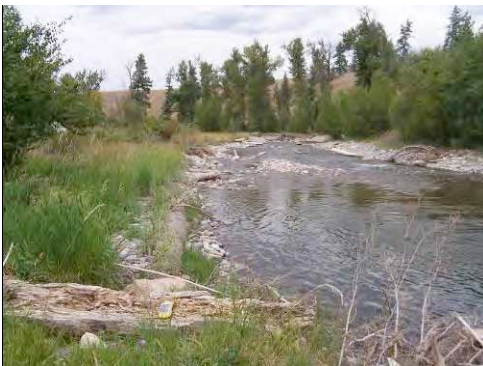
Photo was taken from left bank looking N (0°). Photo corresponds with Photo Monitoring Point 14-2004. The existing green line on the right bank is located at bankfull and consists of wetland shrubs including birch and willows and wetland herbaceous species including sedges and rushes. The existing green line on the left bank is located at bankfull and consists of reed canarygrass and grasses and transitions to native shrubs mostly alder and birch and then transitioning to an upland terrace. Coir fascine 3 is located at photo left center.

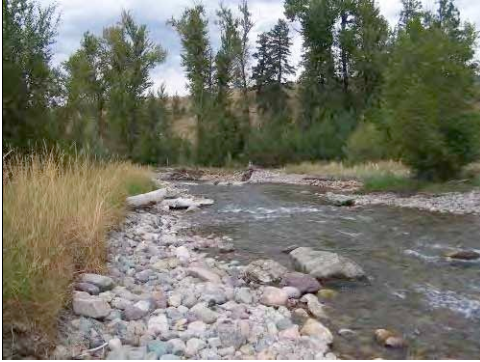
Photo was taken from left bank looking NNE (22.5°). Photo corresponds with Photo Monitoring Point 15-2004. Photo looks downstream to coir fascine 4 on right bank, which marks the downstream end of plugged channel (Photo point 16-2005). The green line along the right bank is located at bankfull and consists of wetland shrubs and wetland herbaceous species. The existing green line along the left bank is located at bankfull and consists of red top and timothy. Herbaceous plugs planted along the channel here were lost during the 2005 flood.

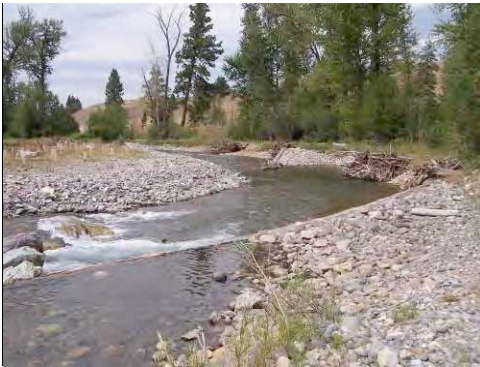
Photo was taken from right bank looking NW (315°). The existing green line along the right bank consists of transplanted sod placed at downstream end of wetland plug and transitions to pine, cottonwood and wetland and upland shrubs. Green line along the left bank is approximately 15 feet above bankfull and consists of planted shrubs and forbs and seeded grass and forb species. Photo shows point bar formation on left bank from Spring 2005 flood event.

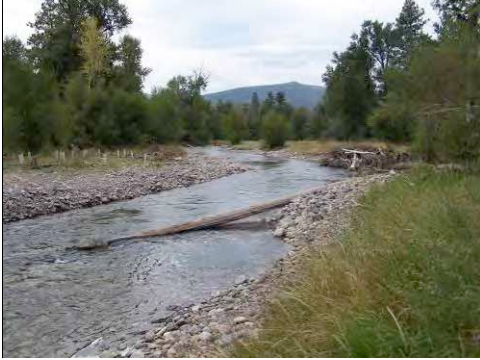
Photo was taken from right bank looking W. Photo is just downstream of Photo Monitoring Point 27-2005. Photo taken to document changes in channel conditions resulting from Spring 2005 flood event.
