# Jocko River Master Plan: Section 2

A guide to ecological restoration activities in the lower main stem Jocko River corridor

## Section 2: Historical, Existing, & Desired Future Conditions

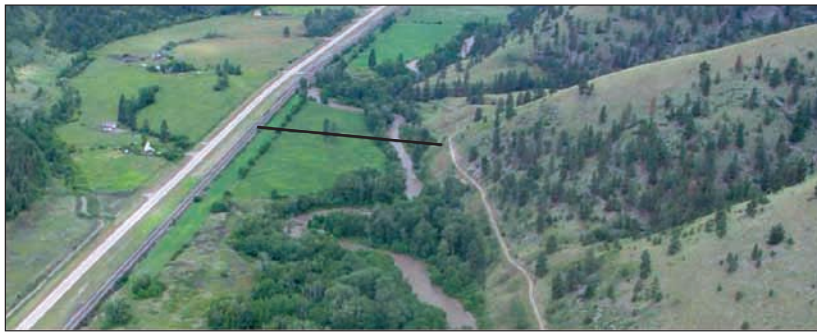
**Figures 2.1.2-2 a and b.**

*A cross section, located on the air photo, contrasts the lateral extent of the floodplain inundation zone for two sections of the Jocko River during the June 4, 2005 flood pulse. The cross section, located in Reach 3, demonstrates the narrow inundation zone for a river reach bounded by artificial levees and bordered by riparian land converted to agricultural purposes.*

Figures 2.1.2-1 through 2.1.2-3 show the interactions between water and the floodplain and how those interactions are influenced by land uses and a modified hydrograph. Where the river maintains full access to the floodplain, the seasonal and interannual range in flows sustains a range of ecological processes. But where the human impacts restrict channel and floodplain interactions, those processes can be disrupted and replaced by unnatural processes such as elevated sediment input or elevated water temperatures.

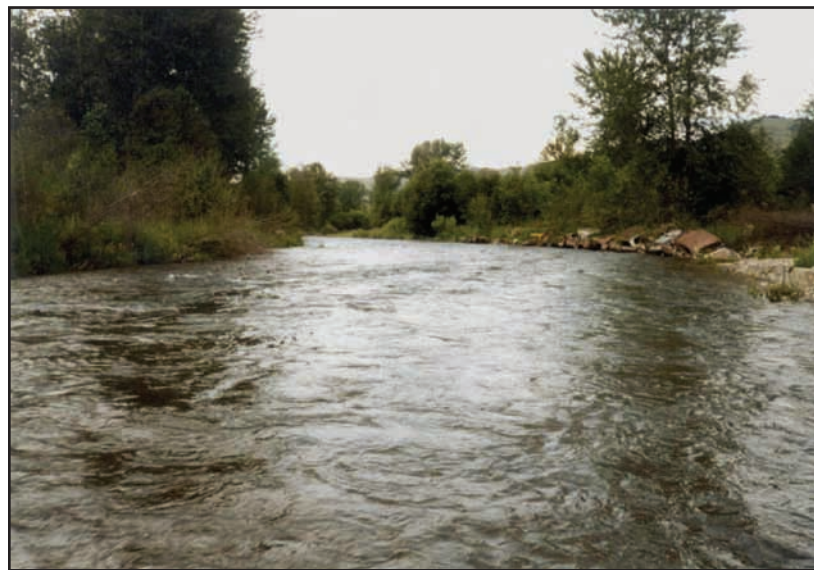
**Figure 2.1.3-2.**

*Twenty percent of Reach Five has constructed levees, 5 percent is channelized, and ten percent is riprapped.*

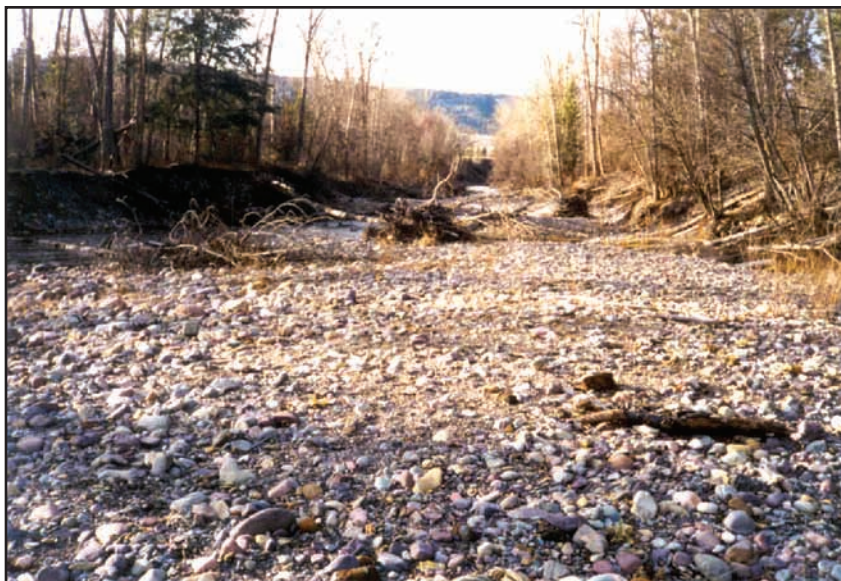
**Figure 2.1.3-3.**  
Down-valley view through a channelized portion of Reach 8.

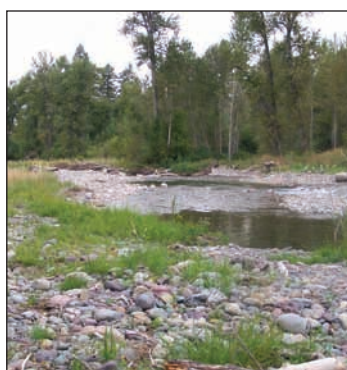
*The black cottonwood/red-osier dogwood community type, one of the reference plant communities, typically occupies much of the floodplain, alluvial terraces, and point bars. Many of these sites are flooded in the spring but may dry deeply by summer's end.*

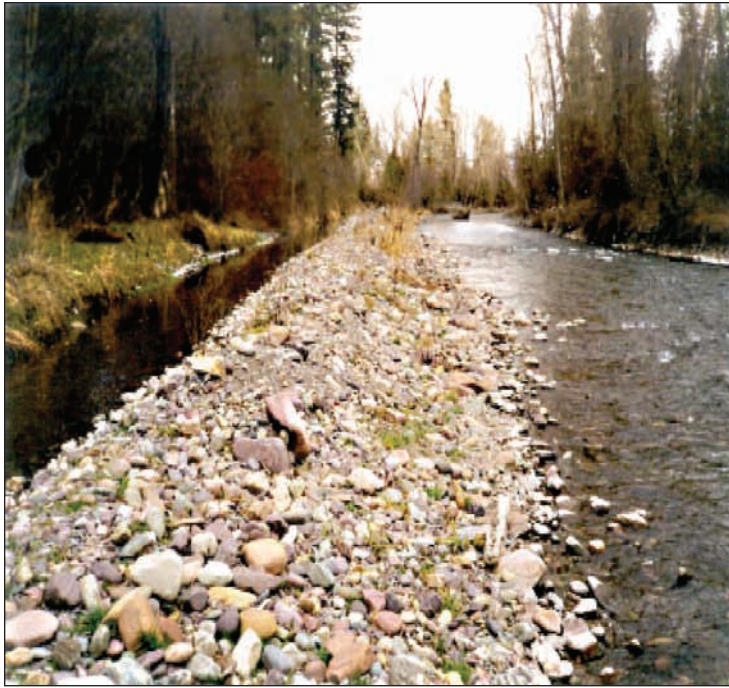
**Figure 2.2.2-2 a.**

*Example of agricultural infrastructure that has initiated stream responses in the lower Jocko River.*

Figures 2.2.2-2 a and b illustrate how agricultural activities have influenced the floodplain of the lower main stem. The view down the Morin Ditch (a), a private irrigation diversion located in Reach Six shows the gravel berm forming the intake to the ditch. Over the years, the producer has extended the berm upstream. It is now approximately 1,000 feet long and restricts the river channel's access to the floodplain. As a consequence, the river has become incised. The aerial view of a segment of Reach Five (b) shows the floodplain during the waning stages of the 1997 flood. The land on the left side of the photo was cleared to improve grazing forage. The photo documents elevated bank and channel instability where the land has been cleared. The result has been elevated bank sediment inputs and increased in-channel sediment storage.

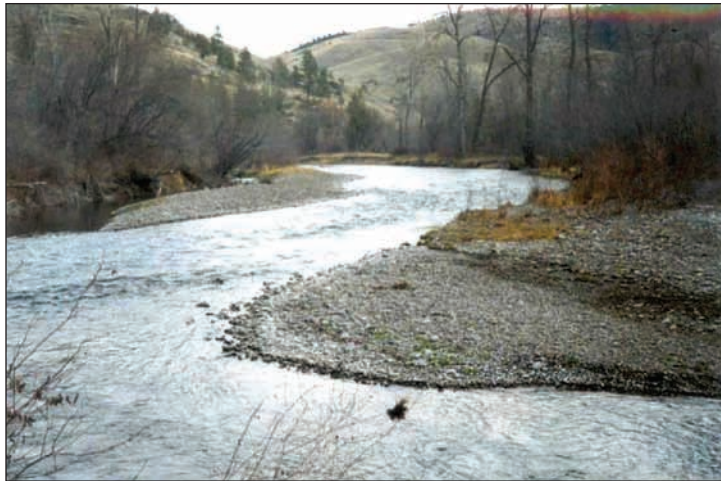
**Figure 2.2.2-4 a.**  
*C stream type*

Figures 2.2.2-4 a, b, and c illustrate this sequence of channel responses. The initial photo shows a section of the Jocko River in a C stream type located in the Lower J canal reference reach. Here, the river has formed alternating bar sequences, and it has access to a wide floodplain.

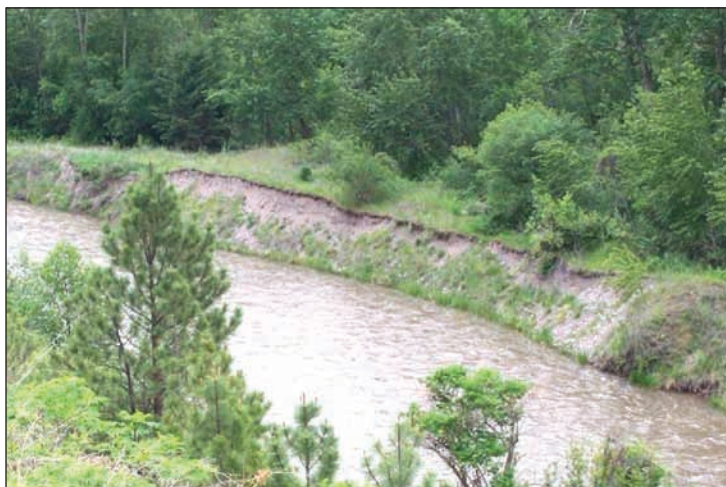
**Figure 2.2.2-4 b.**  
*G stream type*

Figure 2.2.2-4b shows a section of the river that has been channelized and forced against the hillslopes along the National Bison Range. This G stream type section does not have access to its floodplain and has formed a very simplified channel.

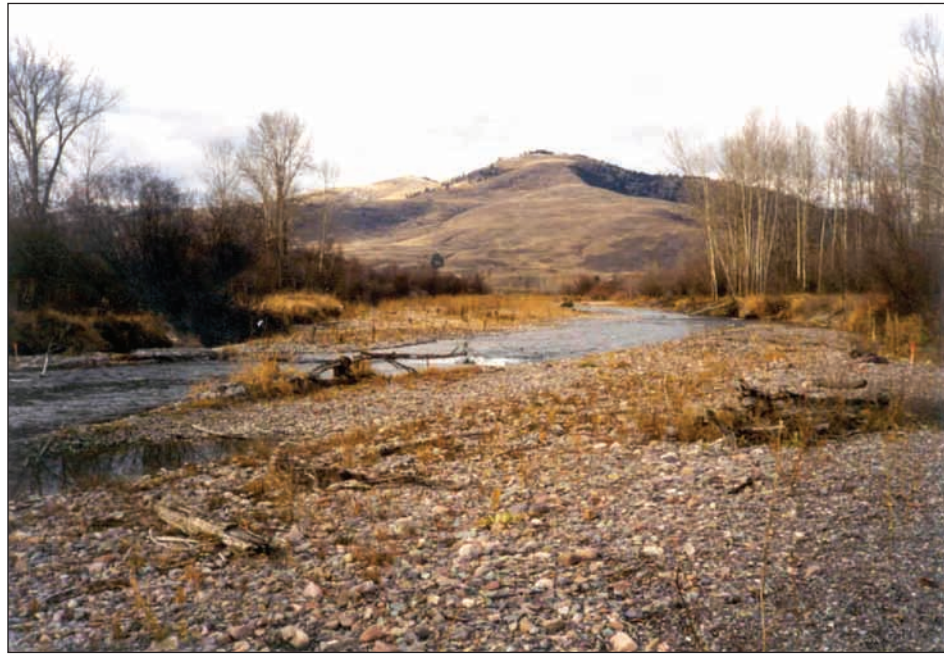
**Figure 2.2.2-4 c.**  
*Historical and modern floodplain elevations.*

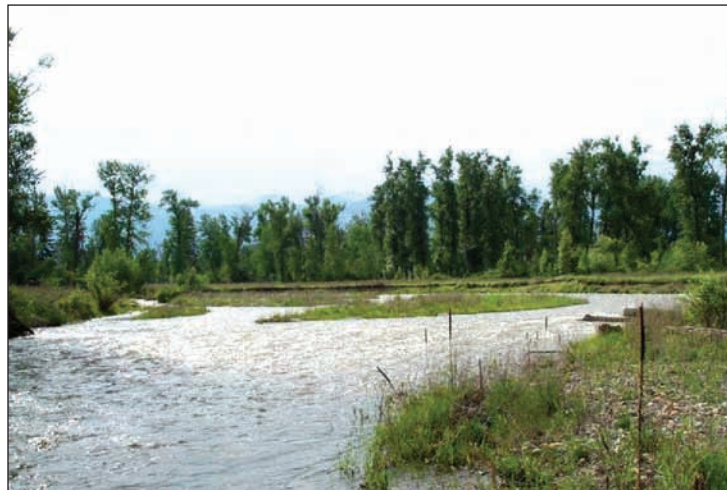
**Figure 2.2.2-5.**  
*D stream type exhibiting sediment storage at mid-channel bars.*

Channelization also affects channel reaches upstream and downstream from the actual channelized reach. The higher-energy gradient of the channelized segment increases sediment transport efficiency. Where the channelized reach ends, a depositional area often forms, creating lateral and mid-channel bed deposits. They cause divergent stream flows and local increases in bank instability. This pattern is apparent on the Jocko River downstream from the fish hatchery. Reaches characterized by abundant bed load deposits are classified as [D stream types](#). Figure 2.2.2-5 shows a D stream type in Reach 8 where sediment is stored as mid-channel bars.

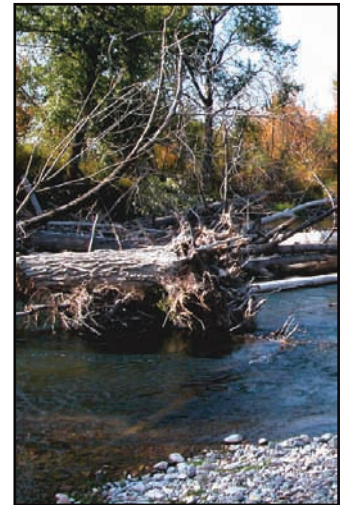
*Large Woody Debris (often abbreviated LWD) is defined as pieces of wood larger than 10 feet long and 6 inches in diameter that are within a stream channel.*

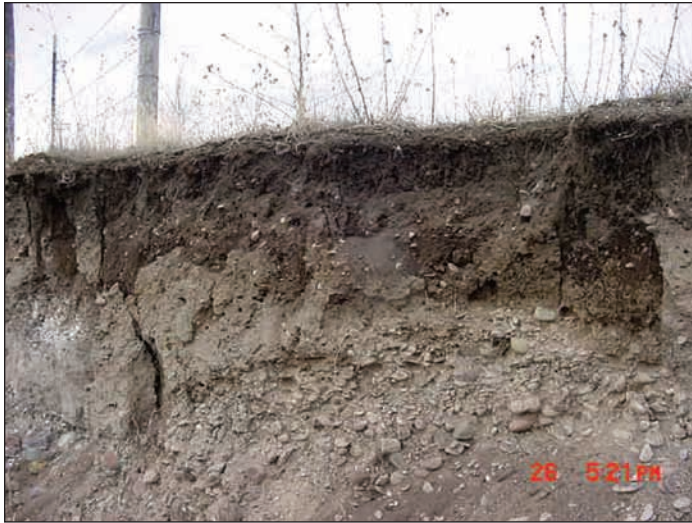
**Figure 2.2.3-1.**

**Jocko Soil Series** – The Jocko soil series ranges from a gravelly loam to a very stony loam (Figure 2.2.3-1). Typical Jocko soils form on glacial outwash material on the upper alluvial surface in the Jocko Valley. In the Schall Flats area in Reaches Five and Six, the series is mapped on active floodplain surfaces and low fluvial terrace surfaces that have similar sedimentologic characteristics as the Jocko glacial outwash.

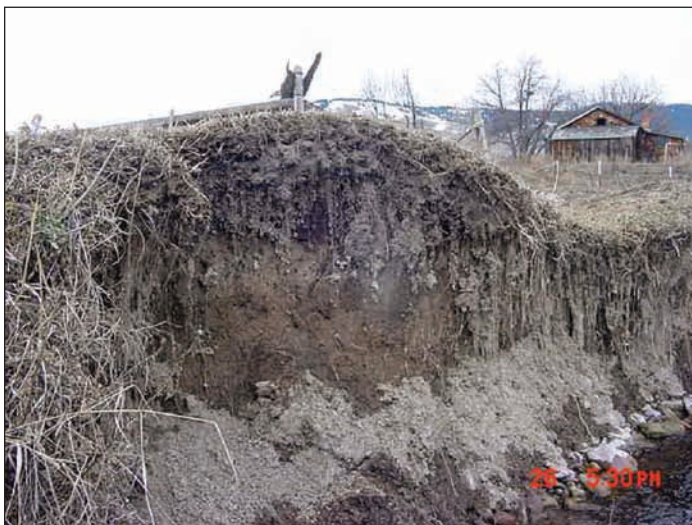
**Figure 2.2.3-2.**

**Lamoose Soil Series** – The Lamoose soil series is an organic-rich loam near the surface that transitions rapidly to extremely gravelly sand at depth (Figure 2.2.3-2). Lamoose soils form on floodplain surfaces on alluvial substrates and are the predominant hydric soil series in the lower Jocko Valley. The series contains actively modified floodplain areas. It is a hydric soil with near-surface water table elevations and redoxomorphic conditions in the B horizon. Lamoose soils are found primarily over [groundwater upwelling](#) areas and in areas with emergent wetland types. High surficial organic matter content is related to high vegetation productivity rates. Organic matter content and organized soil structural properties (weakly prismatic structure) drop off rapidly below 20 inches of depth.

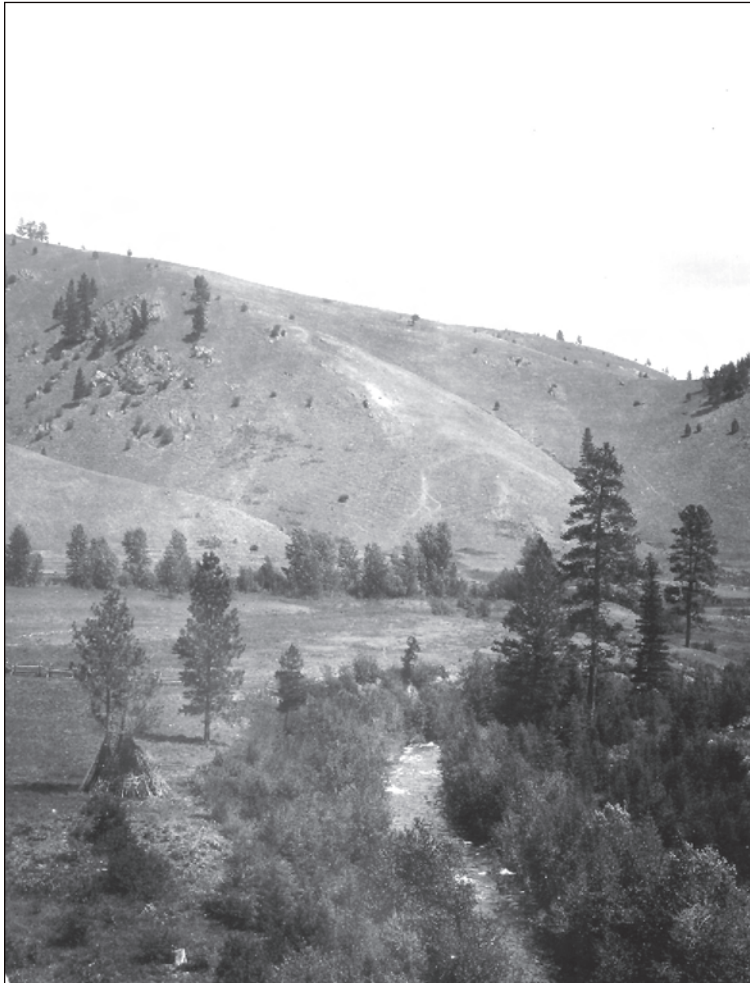
**Figure 2.5.2-1.**

*View upstream of the Jocko River near the main Jocko Canyon mouth, above Teresa Adams Bridge (above Reach Eight), about 1900. The photo was taken by Morton J. Elrod, an early botanist and photographer from Missoula. Note the relatively open stream terrace area, lodge (tipi) constructed of brush, and dense woody cover at water's edge. University of Montana Archives Elrod Collection #73-98.*

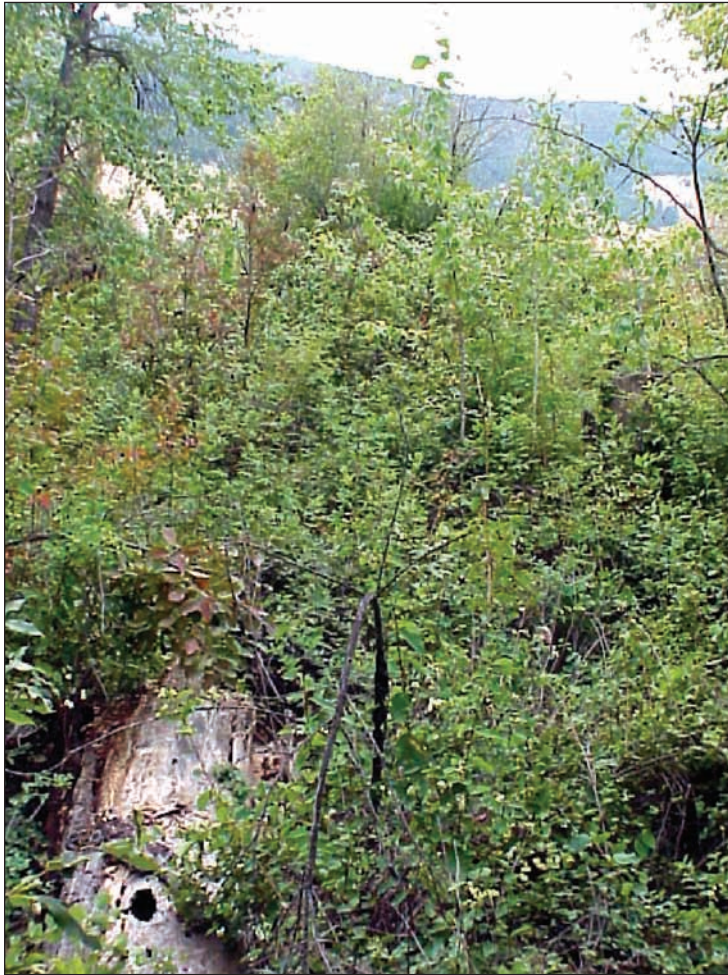
**Figure 2.5.2-2.**

*Typical dense vegetative condition of the black cottonwood/red-osier dogwood (*Populus trichocarpa*/*Cornus stolonifera*) riparian forest community type, located at the National Bison Range Jocko River fishing access site adjacent to Highway 200.*

an almost impenetrable riparian forest, thick with understory shrubs and vines. Where undisturbed to this day, these creek-side riparian communities are still virtually impenetrable because of heavy tree and shrub growth, poison ivy (*Toxicodendron rhybergii*), and white clematis (*Clematis ligusticifolia*) (Figure 2.5.2-2).

Some of the comments made by the surveyors are also informative. U. S. Deputy GLO surveyor E. R. Page repeatedly remarks in his survey notes of riparian areas that he encountered “heavily timbered land and land covered with dense undergrowth and exceptionally difficult to survey (sic)” (Page 1901). This appears to describe the exact vegetation type encountered today within typical, healthy riparian forests along the Jocko River (Figure 2.5.2-2).

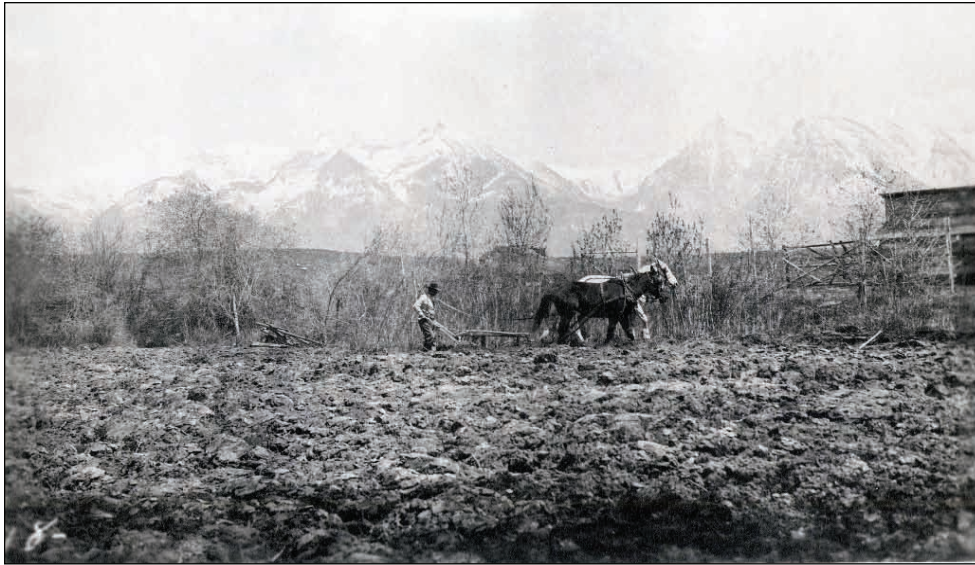
**Figure 2.5.2-3.**

*Plowing of a former wetland area on the Tellier Homestead on Mission Creek, the main drainage north of the Jocko River Drainage, 1920. This was the fate of many wetland types in the Jocko River floodplain as well. Salish-Pend d'Oreille Culture Committee Archive #A-0010.*

It is likely, given the type of disturbances native plant communities have been subjected to over the past 150 years, that the number of communities expressed within each reach has been reduced. For example, agricultural practices have almost certainly removed native herbaceous community types from many reaches. These areas were easily converted to pastures and fields with minimal draining and little or no woody plant clearing. They also tend to have productive, organic-rich soils (Figure 2.5.2-3), so they were probably the first lands to be put into agricultural production.

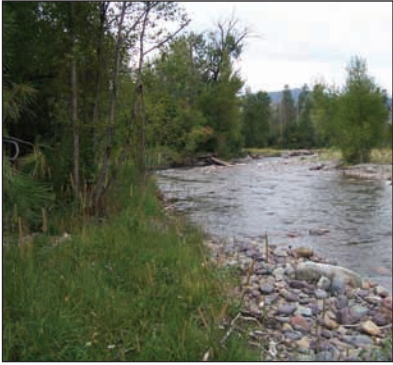
Black cottonwood/red-osier dogwood Community Type.

This forest type occupies alluvial terraces of major rivers and streams, point bars, side bars, mid-channel bars, delta bars, an occasional lake or pond margin, and even creeps onto footslopes and lower subirrigated slopes of hilly or mountainous terrain. Many of these sites are flooded in the spring and dry deeply by summer's end; capillary action keeps upper portions of soil profile moist. Other sites are merely subirrigated. *Populus balsamifera* ssp. *trichocarpa* dominates the overstory with cover values ranging from approximately 12-90 percent, though the modal range, at least in Montana is 40-60 percent. *Populus angustifolia* is a subordinate canopy species in the eastern portion of the range, and *Populus tremuloides* and *Betula papyrifera* occur as subordinates in the western portion. The shrub layer comprises at least 25 percent cover with *Cornus sericea* diagnostic for the type and having anywhere from 1-90 percent cover; other shrub taxa with high constancy include *Symphoricarpos* spp., *Rosa* spp., *Salix* spp., *Crataegus* spp., *Amelanchier alnifolia*, and *Alnus incana*. There are no graminoids exhibiting high constancy, though any one of a number of disturbance-associated exotics can manifest high coverages. *Maianthemum stellatum*, *Galium triflorum*, *Solidago canadensis*, and *Equisetum* spp. are the only forbs that exhibit even relatively high constancy across the range of the type. This is a successional community that colonizes moist, newly deposited alluvium exposed to full sunlight; in the absence of fluvial disturbance it is capable of developing into conifer-dominated communities belonging to alliances as diverse as *Thuja plicata*, *Picea* spp. and *Juniperus scopulorum*. Adjacent wetter sites are dominated by a suite of wetland *Salix* spp., *Alnus incana*, wetland-associated *Carex* spp. often including *Carex utriculata*, *Carex aquatilis* and *Carex buxbaumii* or *Typha latifolia*-dominated communities. Adjacent drier sites are dominated by *Populus balsamifera* ssp. *trichocarpa* or *Populus tremuloides* types or any of a vast array of conifer-dominated types that are capable of growing within the elevational zone occupied by the *Populus balsamifera* ssp. *trichocarpa* / *Cornus sericea* Forest (Montana Natural Heritage Program 2003).

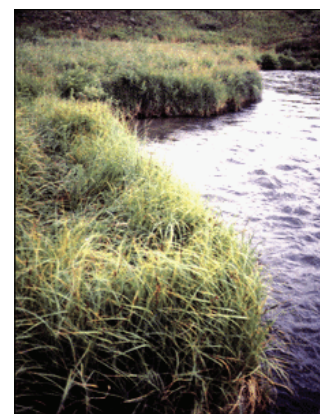
Beaked Sedge Habitat Type  
(courtesy Ecological Solutions Group)

This wetland association is found throughout much of the western U.S. Stands occur in montane and subalpine areas around the edges of lakes and beaver ponds, along the margins of slow-moving reaches of streams and rivers, and in marshy swales and overflow channels on broad floodplains. Sites are flat to undulating, often with a hummocky microtopography. The water table is usually near the surface for most of the growing season. There are a wide variety of soil types for this association ranging from saturated organics or fine silty clays to clays over cobbles and alluvium to fine-loamy and sandy-skeletal. Mottling often occurs near the surface because of the high water table. The vegetation is characterized by a moderately dense to dense perennial graminoid layer dominated or codominated by *Carex utriculata* (20 to 99 percent cover). Stands often appear to be nearly pure *Carex utriculata*, but a variety of other graminoid species may be present as well. Other *Carex* species present include *Carex lenticularis* and *Carex microptera*, but usually with low cover. Other graminoid species that may be present include *Calamagrostis canadensis*, *Glyceria striata*, and *Juncus balticus*. Sparse forb cover can include *Geum macrophyllum*, *Mentha arvensis*, and *Mimulus guttatus*. Scattered *Salix* spp. shrubs may be present because these riparian shrublands are often adjacent. *Salix* species vary depending on elevation and geography (Montana Natural Heritage Program 2003).

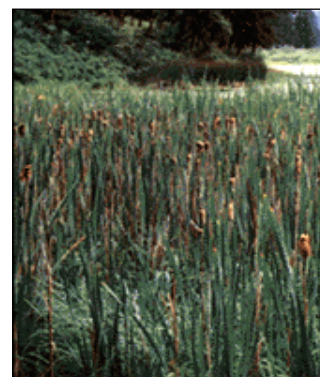
Common Cattail Habitat Type  
(courtesy Ecological Solutions Group)

The common cattail habitat type occurs in areas where the soil is saturated or submerged during a significant portion of the growing season. Hansen et al. (1995) indicate that it is found along pond margins, ditches, oxbows, and backwater areas. On the floodplain of the lower main stem, it also occupies areas managed for agriculture where groundwater is at the soil surface. These sites may be formerly drained areas where the drainage ditches have filled in, areas that were graded or slightly excavated for agricultural purposes, or natural wet areas where shrub removal has reduced evapotranspiration and changed the [hydroperiod](#).

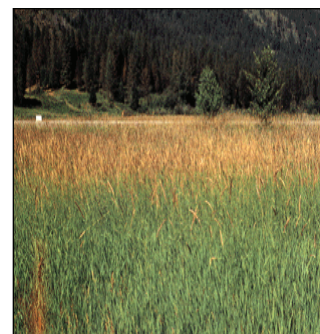
Reed Canarygrass Habitat Type  
(courtesy Ecological Solutions Group)

Reed canarygrass is the dominant species and usually forms monotypic, stable stands. Stands that include small components of black cottonwood, rose, nightshade (*Solanum dulcamara*), other grasses, and sedges still function as stable reed canarygrass habitat types. The reed canarygrass habitat type requires active restoration (shade, mulching, herbicide and/or active revegetation) to shift it to a more complex ecological type.

Maurer et al. (2003) demonstrated that reed canarygrass most effectively replaces native vegetation when natural microtopography is simplified, often as a result of sediment burying native wetland

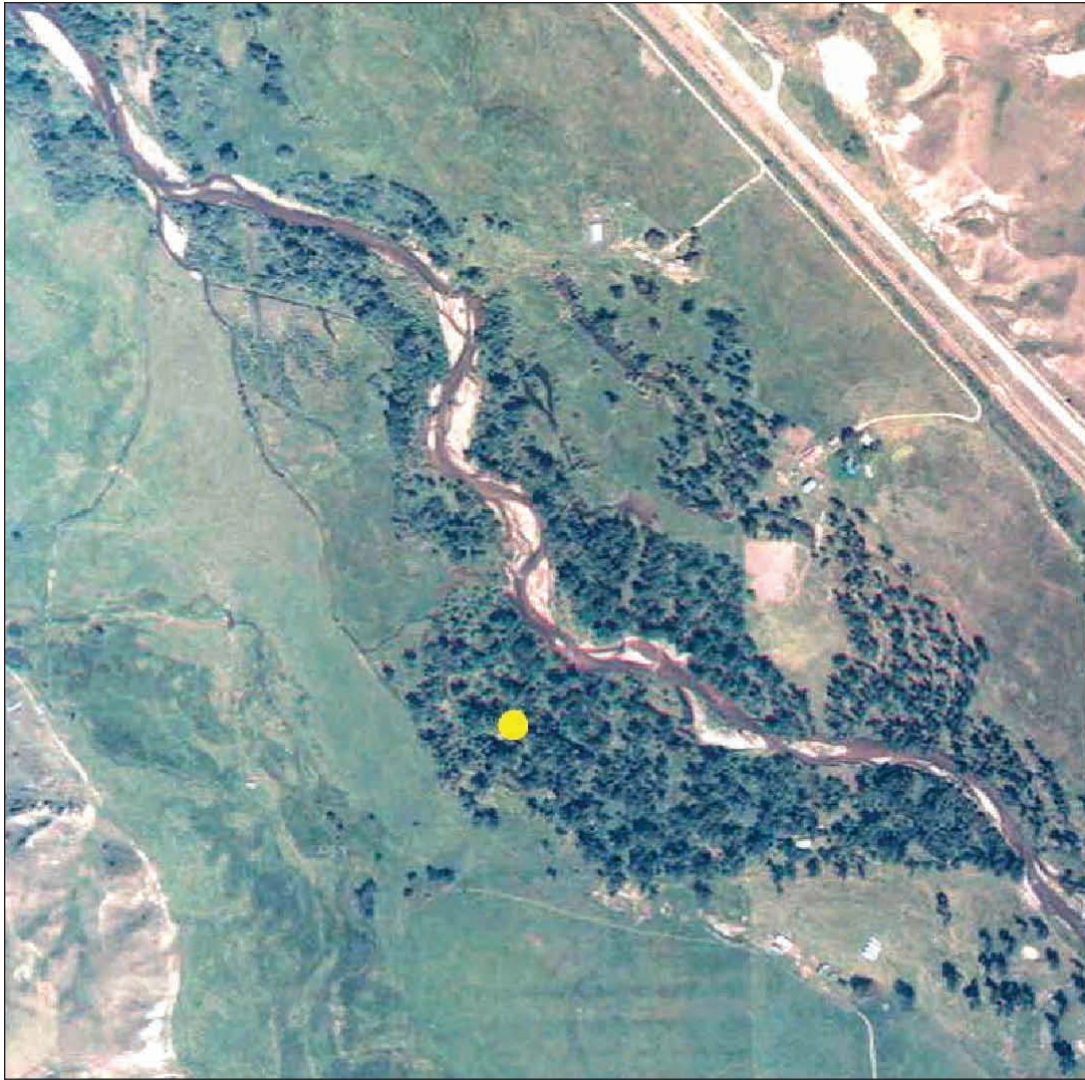
**Figure 2.8.2-1**

Bald eagles are particularly sensitive to human disturbance near nesting locations. The Montana Bald Eagle Working Group Management Plan outlines guidelines to be followed to reduce nest failure. One nest is currently active within Reach Five (Figure 2.8.2-1). The Tribes evaluate all human activities occurring between February 1 and August 15 within 2.5 miles of the nest site.

*Approximate location of a bald eagle nest in Reach Five.*

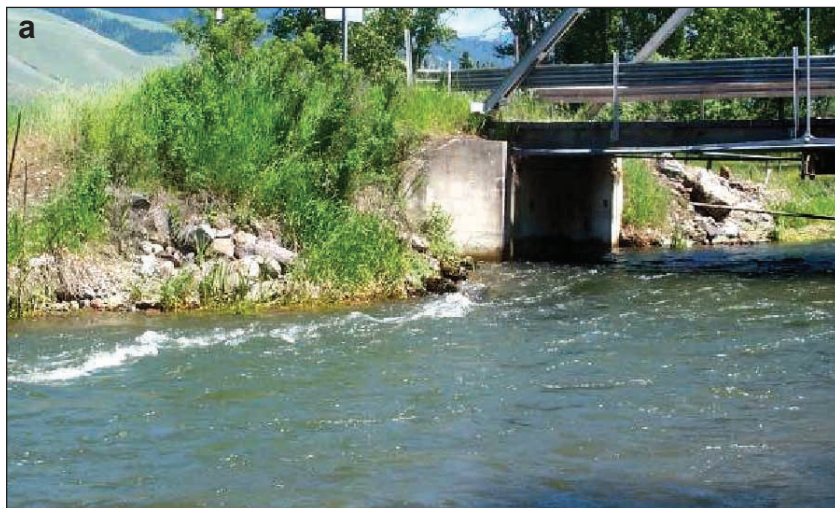
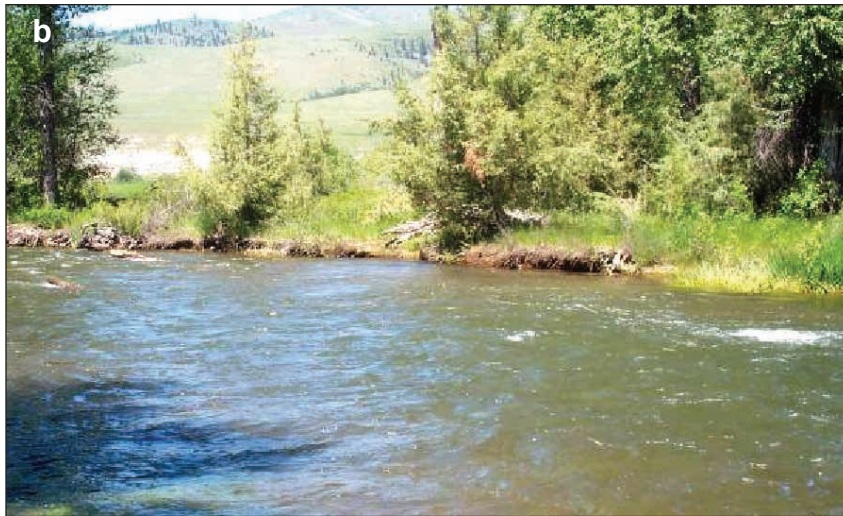
**Figures 2.9.3-1 a and b.**

The South Valley Creek Road Bridge is in Reach Five. Reach Five has C4 and D4 stream types (Rosgen 1996). We observed several stream impairments in the vicinity of the bridge, including bank erosion and abutment scour. The single lane structure consists of a wood plank deck and two concrete abutments that lie within the bankfull channel (Figure 2.9.3-1 a and b). Abutment scour, caused by the skew angle ( $45^{\circ} \pm$ ) between the bridge and the river, is a problem on the east abutment. As a result, rip-rap has been dumped along the downstream east bank. We observed bank erosion on the east bank downstream of the rip-rap. For these reasons and because of significant floodplain constriction and backwater effects, this bridge has a major impact on the river.

*Scour at the east abutment on the South Valley Creek Road Bridge (a). Bank erosion downstream of the east abutment (b).*
