# Jocko River Master Plan

## Appendix C: Demonstration Reach Phase I Monitoring Plan

# **JOCKO RIVER DEMONSTRATION REACH PHASE I**

## **Monitoring Plan and Annual Reporting 2006**

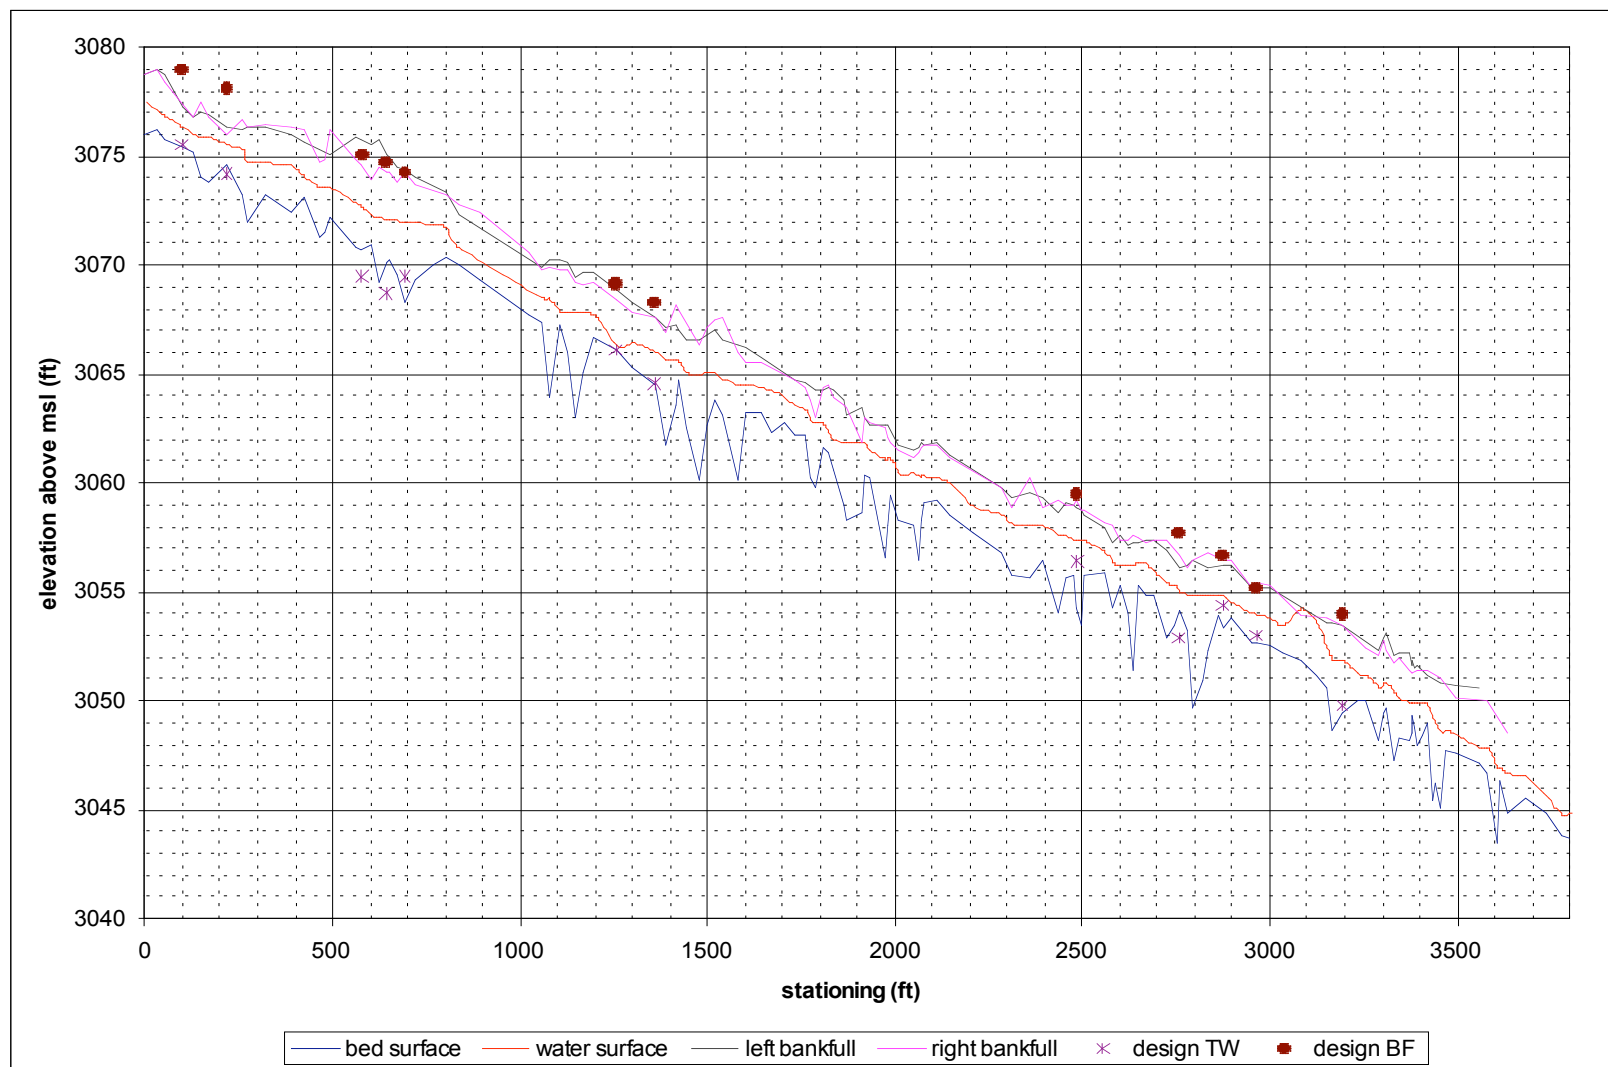
**Figure 2.** Demonstration Reach longitudinal survey conducted during implementation monitoring (11/04) to document as-built conditions

Figure 1 shows the results of the long profile survey through the Demonstration Reach conducted for baseline monitoring prior to construction of the project. This profile includes both Phase I and future phases of the Demonstration Reach. The lack of pools is apparent on this profile. Figure 2 is a longitudinal profile through the reach surveyed during implementation monitoring to document as-built conditions. This profile shows bed and water surface elevations, bankfull elevations, and select design elevations to compare with as-built conditions. The overall slope is 0.008 ft/ft, similar to the pre-

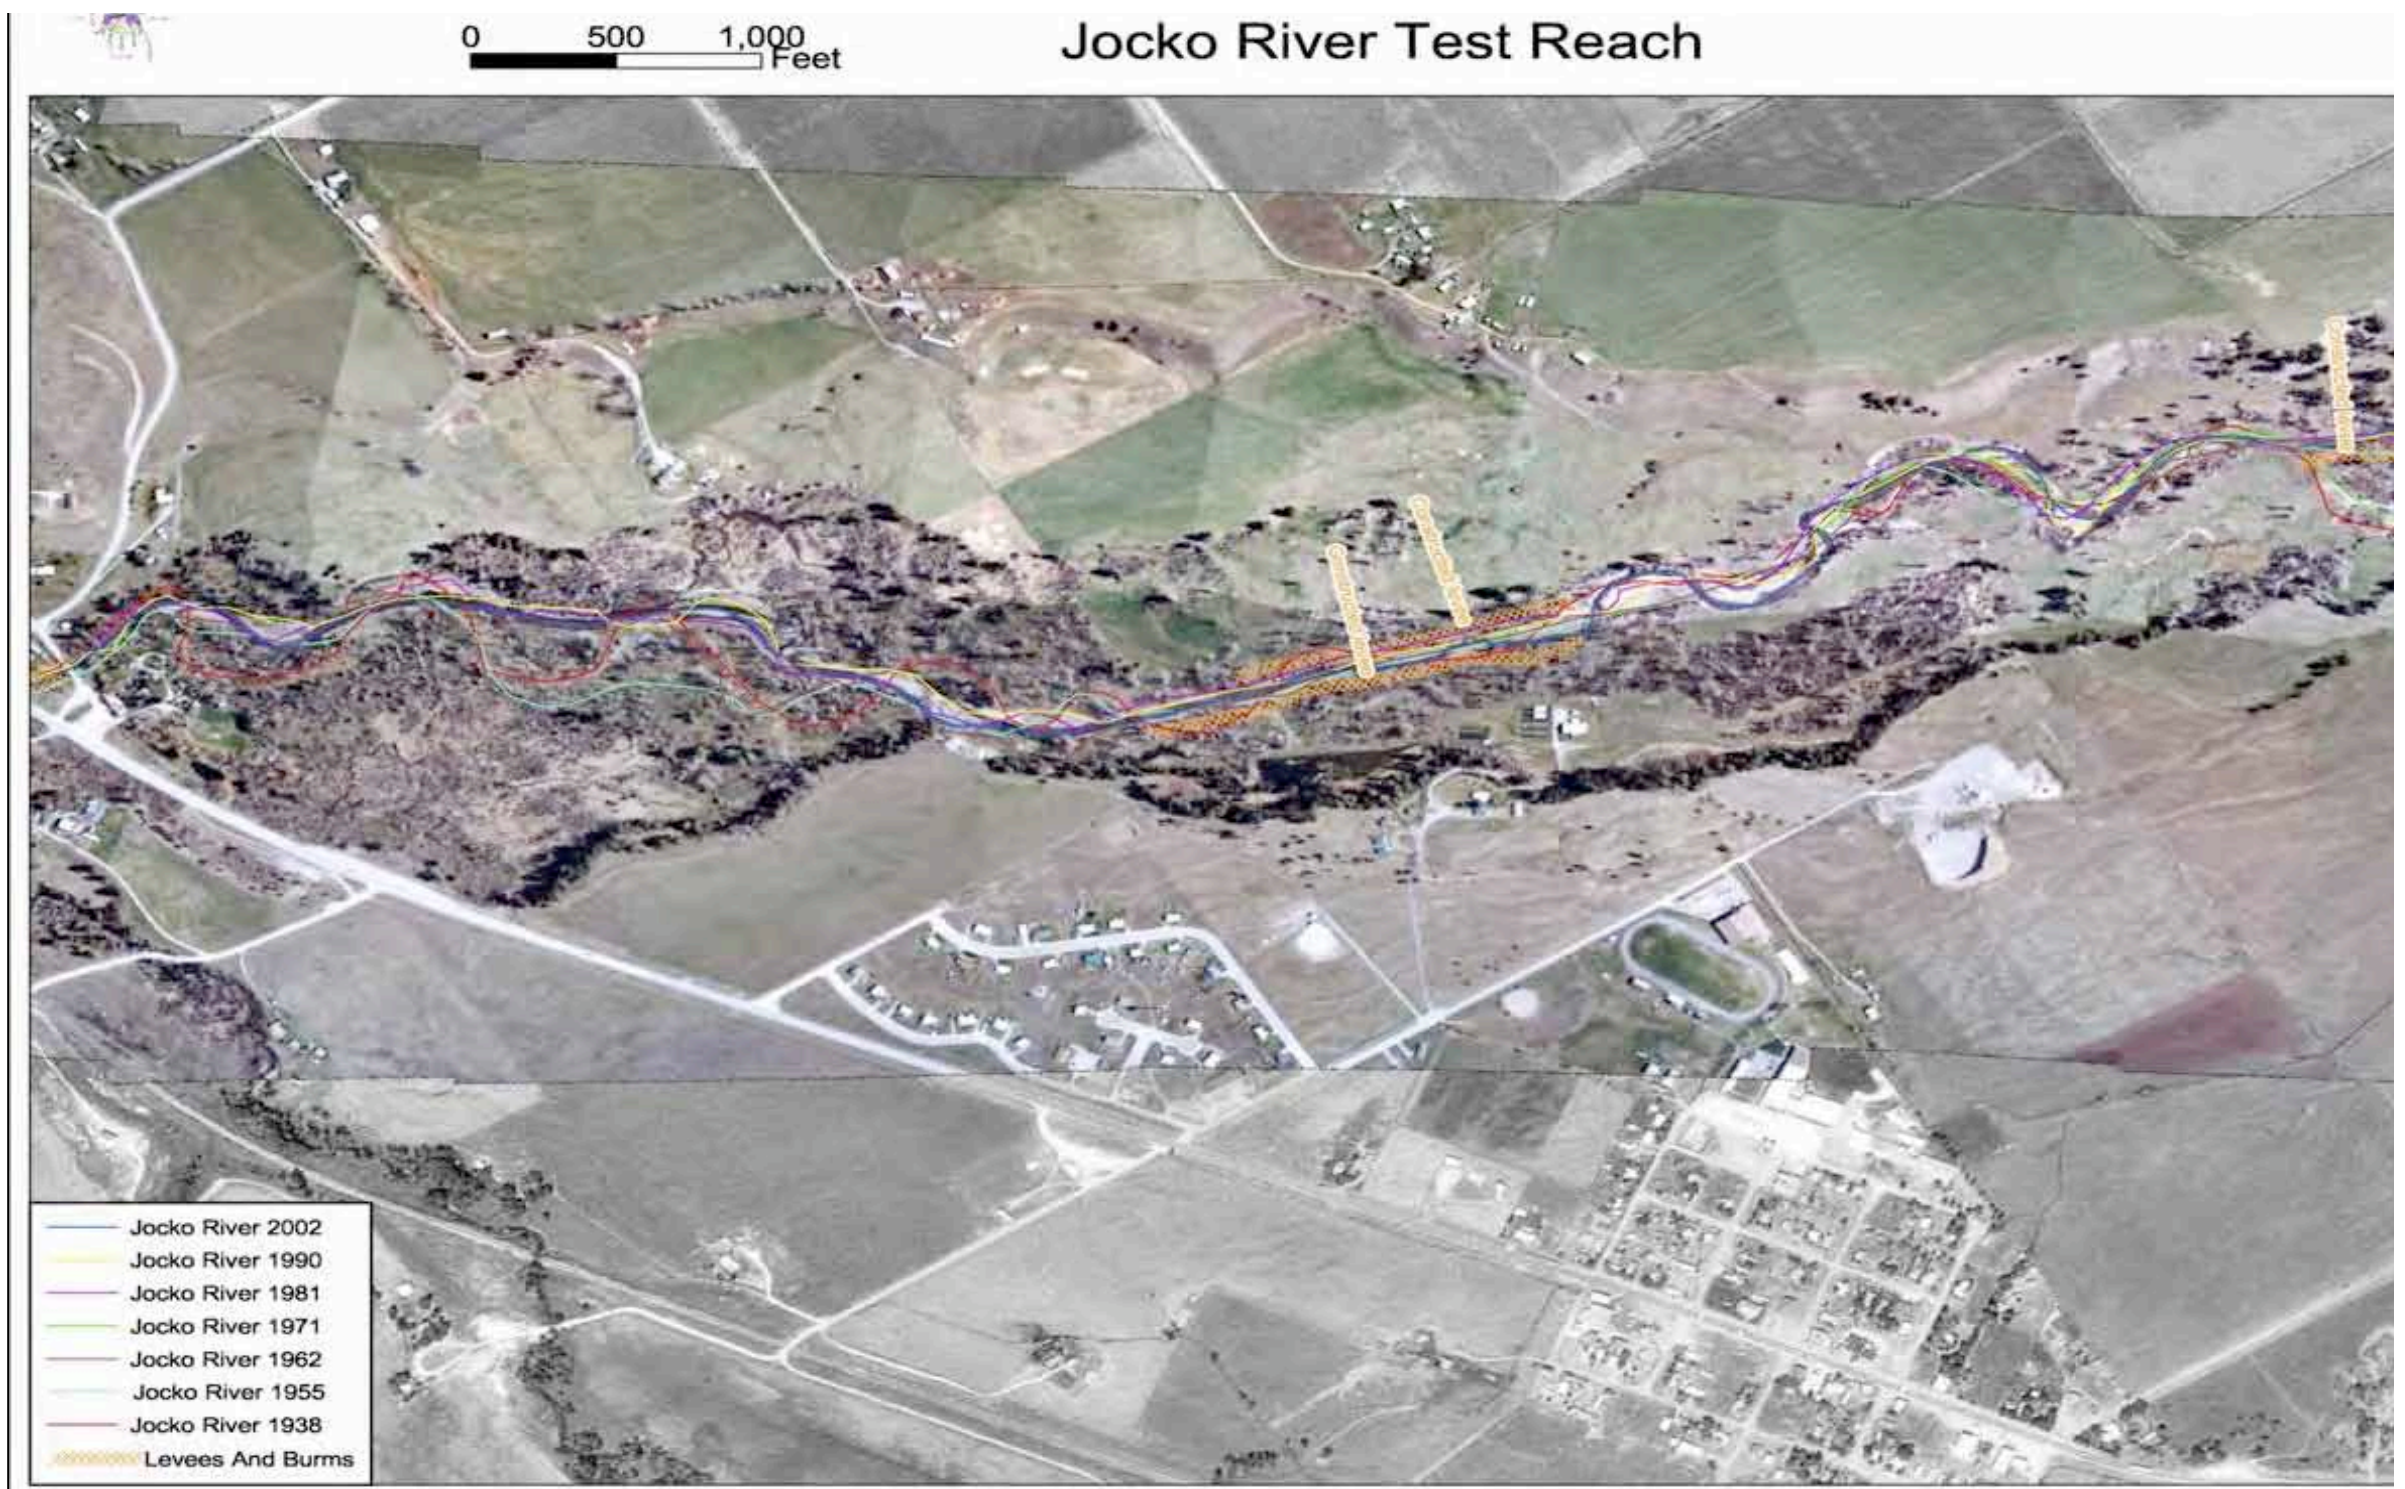
**Figure 11.** Baseline aerial photo of Jocko River Demonstration Reach including all phases of the project showing locations of historic channel traces and levees.

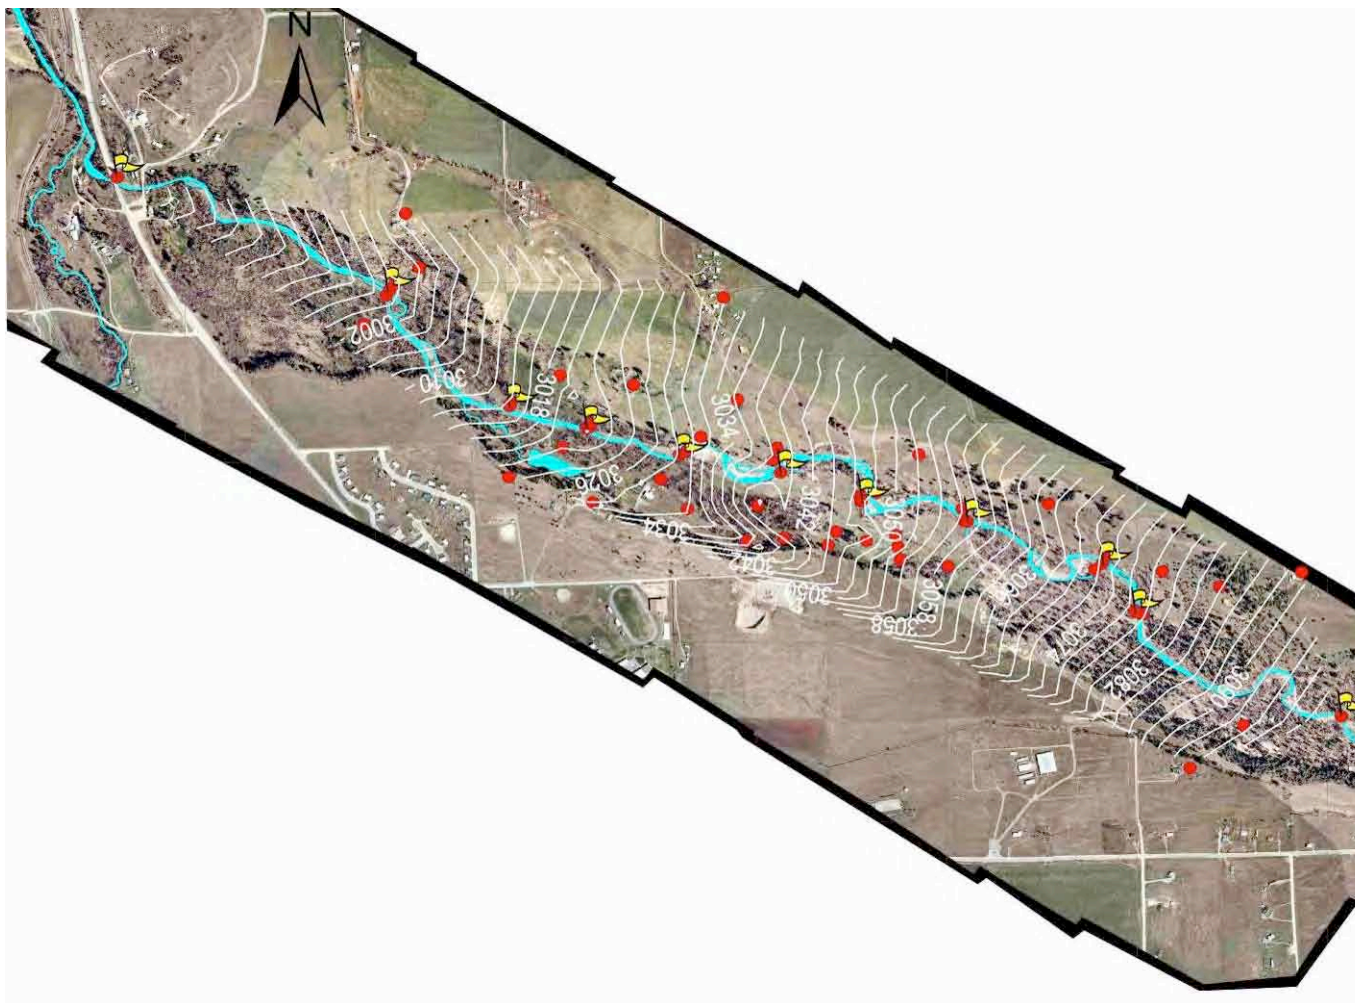
Figures 12 and 13 show baseline water table elevations contours for the Demonstration Reach. Red dots on the map are the locations for shallow wells and the yellow flags represent stream gage locations. The maps show the flow field for floodplain groundwater and the seasonal migration of the gaining and losing reaches of the river. The large spring discharge area utilized by the Arlee Fish Hatchery shows as a groundwater upwelling area for both time periods. We will continue monitoring groundwater throughout the project reach to determine effects from the project.

**Figure 12.** Shallow groundwater baseline monitoring map for the Demonstration Reach project area created from data collected from groundwater monitoring wells in February 2004. Well locations are shown in red. Yellow flags represent stream gage locations.

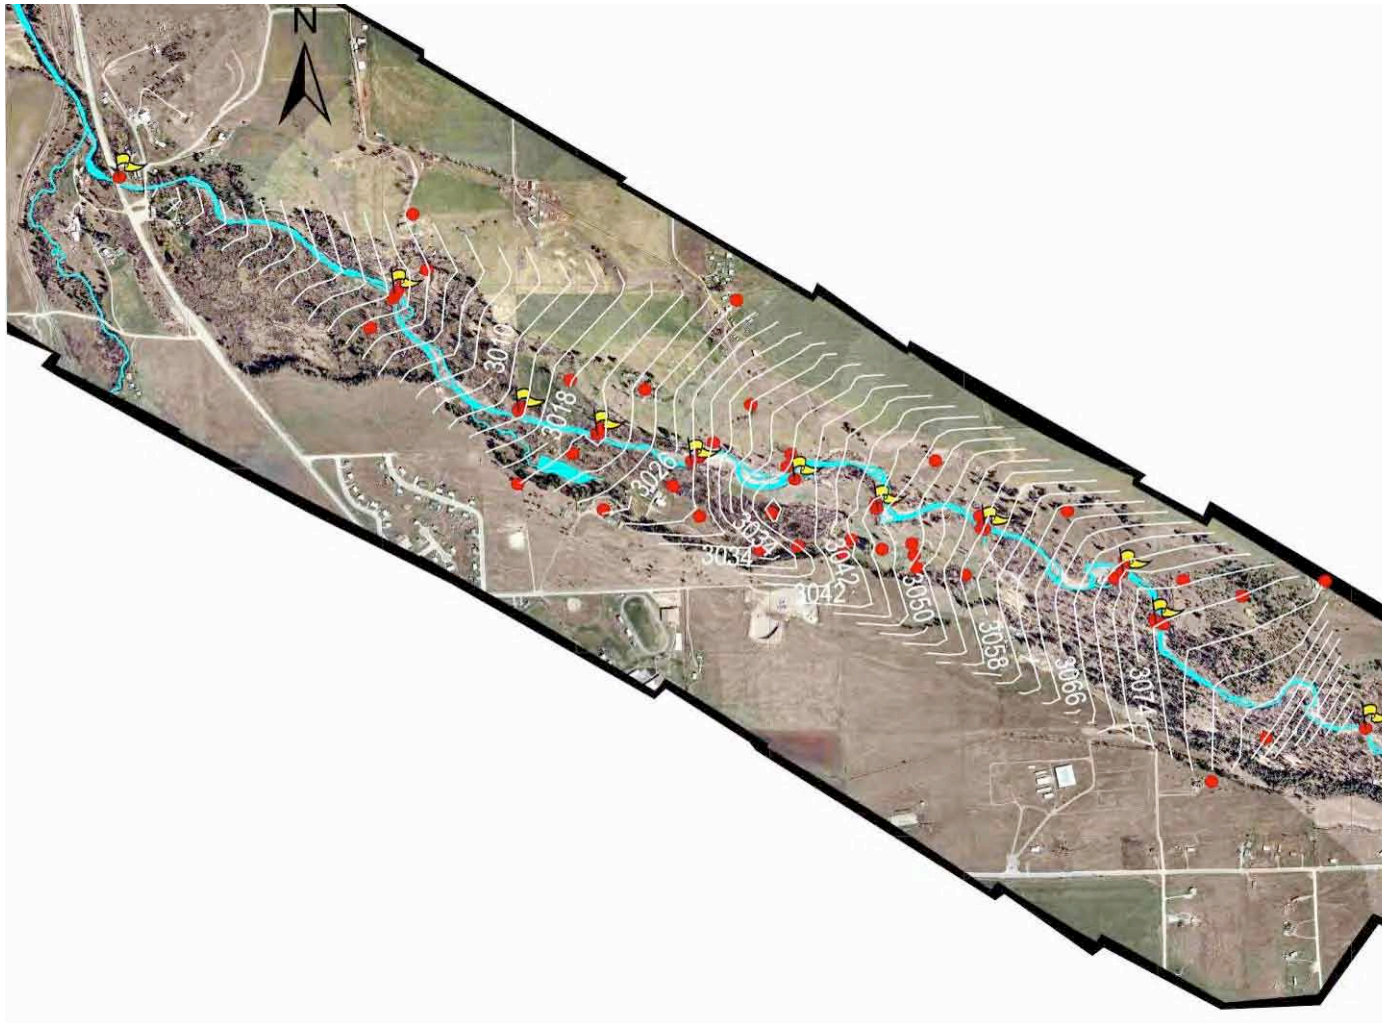
**Figure 13.** Shallow groundwater baseline monitoring map for the Demonstration Reach project area created from data collected from groundwater monitoring wells in July 2004. Well locations are shown in red. Yellow flags represent stream gage locations.

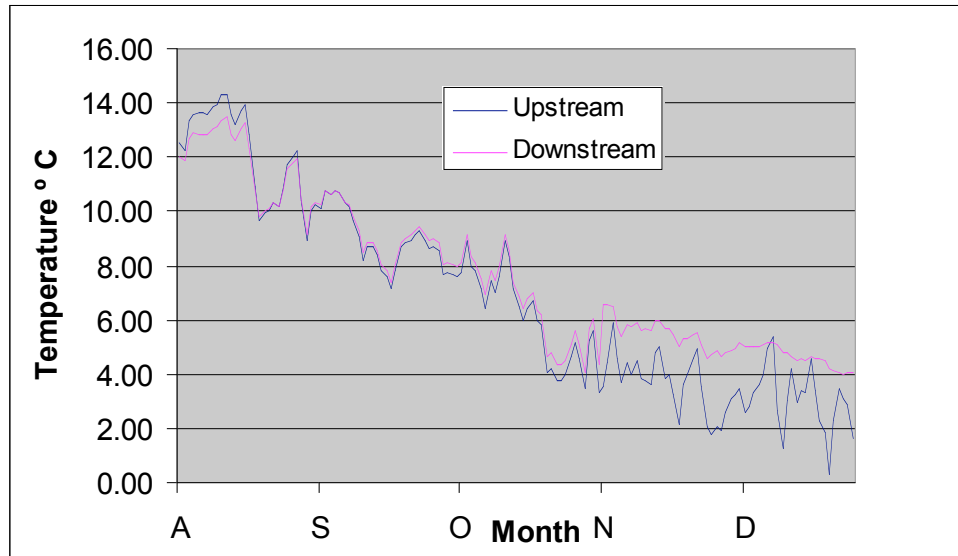
The data we collected during 2004 suggest that when mean daily water temperatures exceeded approximately 11 to 12 °C, upstream areas were up to 1 °C warmer, whereas when temperatures were low (e.g., < 6 °C) the upstream area was up to 4 °C cooler, demonstrating the moderating effects of large groundwater inputs immediately downstream of the project area (Figure 14). One of the goals of the Demonstration Reach project was to extend the gaining reach upstream into the restored area by increasing groundwater-surface water interactions, thus moderating temperature regimes. Such a temperature shift would best be detected by examining differences between water and air temperatures above and below the reach before and after restoration. However, we currently do not monitor local air temperatures. Our hypothesis was that increased floodplain-channel interactions resulting from the project might elevate water levels in the floodplain aquifer and result in a greater temperature differential between the upstream and downstream monitoring stations. Thus, we will continue temperature monitoring at the upper and lower boundaries of the Demonstration Reach as a means of effectiveness monitoring.

**Figure 14.** Mean daily water temperatures at monitoring locations immediately upstream and downstream of the Jocko River Demonstration Reach near Arlee, Montana during August through December 2004. Restoration actions generally occurred from August through October.

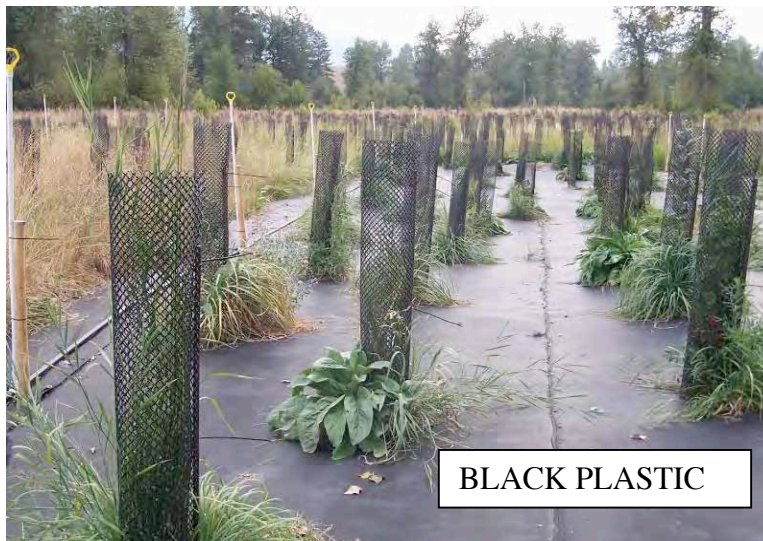
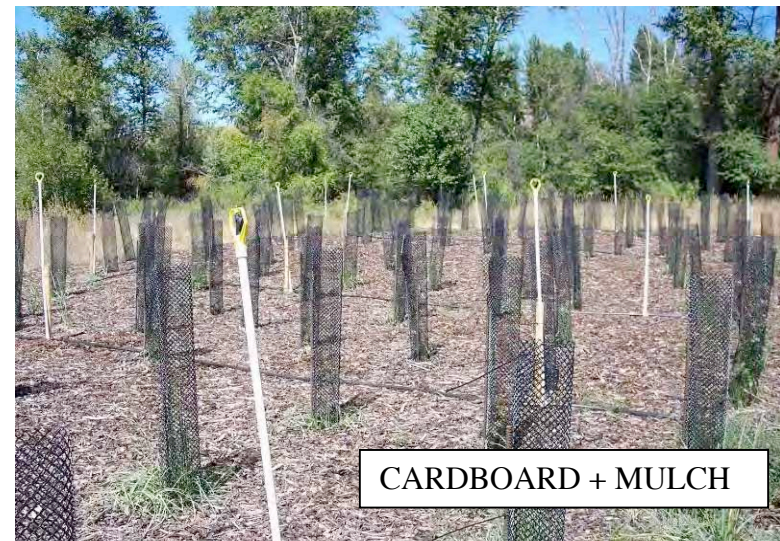
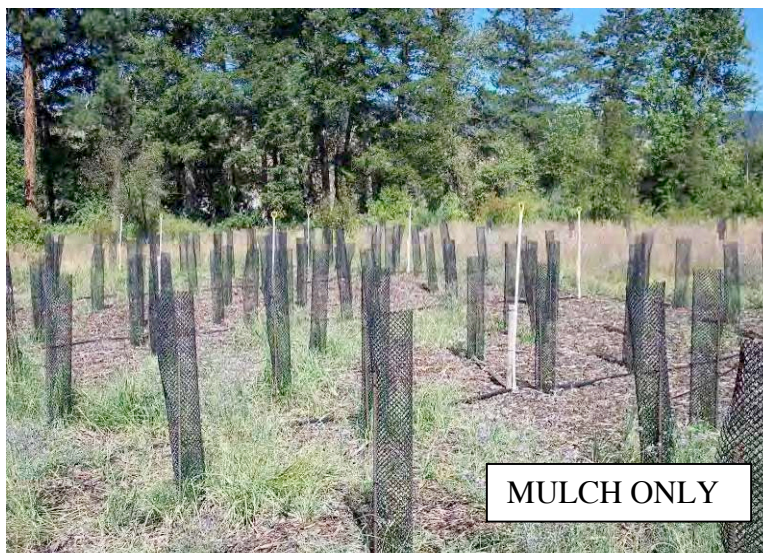
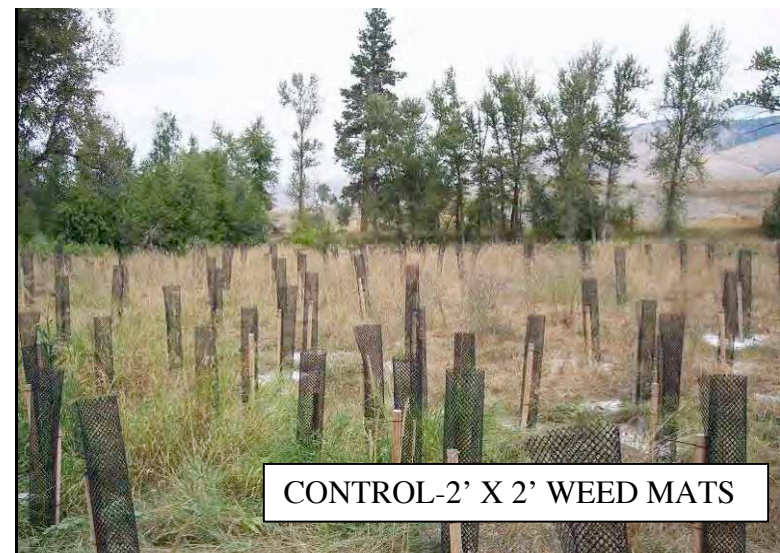
**Figure 19.** Photographs of experimental weed treatments implemented at the Demonstration Reach Phase I.

The results of the experimental weed treatment monitoring showed that all experimental plots had greater survival compared to the control plot (Table 18). The cardboard with mulch and black polyethylene fabric treatments had greater survival (Figure 20) and greater diameter/stem growth metric values (Figure 21) compared to control and mulch only plots (Figures 20 and 21). For the growth data, Wood's rose and snowberry are reported separately. Because chokecherry growth in the Black Plastic 2 treatment was considerably higher than other species, a bar excluding chokecherry is included to evaluate the influence of chokecherry on overall growth. The mulch only treatment plots had slightly lower growth metric values compared to control plots (Figure 19). The black polyethylene fabric and cardboard treatments also had very low exotic plant species coverage compared to control plots (Table 17). Figure 19 shows photos comparing the four treatment plots.

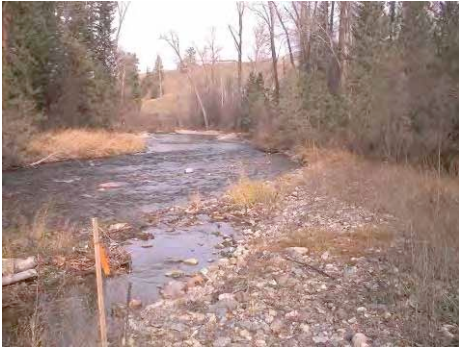
### PHOTO MONITORING POINT 1-2004

Photo was taken from right bank at Station 91+54 looking NNW (337.5°). Photo and notes extend to Station 88+50. The existing green line along the right bank is located at bankfull and consists of predominantly reed canarygrass and knapweed (approx. 50 feet wide). Community type transitions to cottonwood, pines, and shrub riparian vegetation beyond this. No vegetation treatments were implemented in this area.

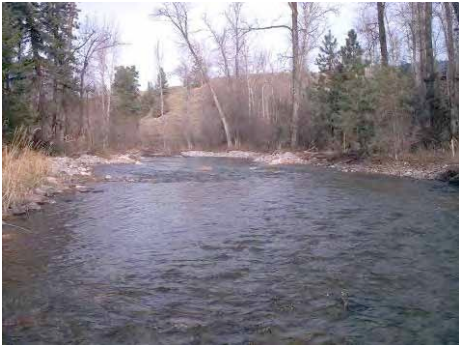
### PHOTO MONITORING POINT 2-2004

Photo was taken from left bank at station 90+00 looking N (0°) to station 88+50. The existing green line is at bankfull reed canarygrass and knapweed on the left bank (approx. 20 feet wide). Community type transitions to pine and rose upland community. No vegetation treatments were implemented in this area. Structure in channel is rock cross vane (most upstream structure).

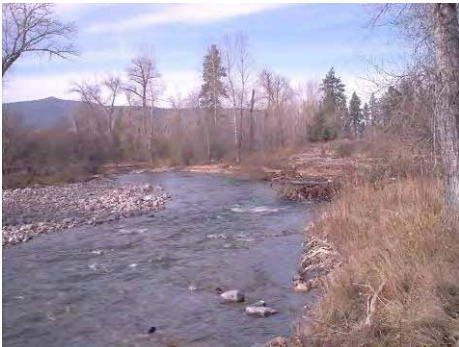
### PHOTO MONITORING POINT 3-2004

Photo was taken from right bank at station 85+50 looking NW (315°). The existing green line along the right bank is located at bankfull and consists of knapweed and red top (approx. 10 feet wide). Community type transitions to pine and cottonwood with a shrub understory. No vegetation treatments were implemented in this area. Left bank is newly created cobble point bar. Green line is approx. 15 feet from high water mark and consists of existing vegetation-cottonwood and pine with a shrub understory. Herbaceous plugs and native shrubs were planted along left bank.

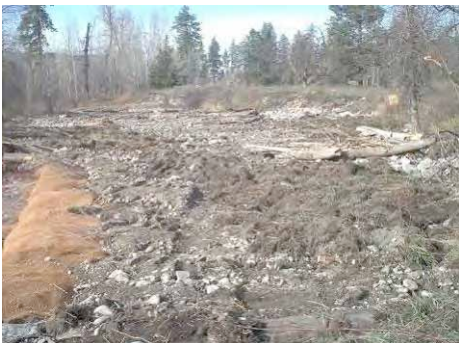
### PHOTO MONITORING POINT 4-2004

Photo was taken from right bank at Station 84+00 looking NNW (337.5°) into abandoned channel area filled with cobble and top soil. The existing green line is located 75 feet from the right edge of the newly constructed channel. The existing green line corresponds to the former right channel bank consists of predominantly knapweed and scattered shrubs (approx. 50 feet wide). Native shrubs, trees and herbaceous wetland species were planted in the bare floodplain area.

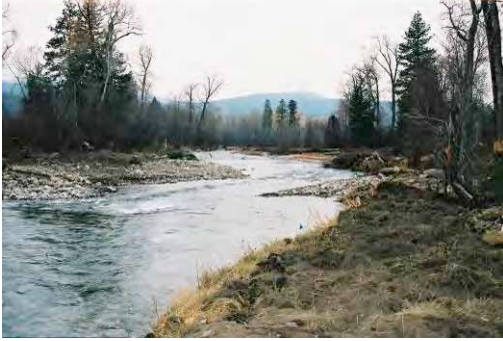
PHOTO MONITORING POINT 17-2004

Photo was taken from right bank at Station 65+50 looking SW (225°). The existing green line along the right bank is located approximately 15 feet from bankfull and consists of pines, cottonwoods and upland shrubs and herbaceous species (50 feet). Community type transitions to upland dominated by pines and upland herbaceous species and knapweed. The existing green line along the left bank is located approximately 10 feet above bankfull (downstream of point bar) and consists of cottonwoods, pines and wetland and upland shrubs and herbaceous species (50 feet). Community type transitions to open floodplain area dominated by upland herbaceous species and knapweed and then to herbaceous wetlands. No vegetation treatments were implemented in this area in Fall 2004.

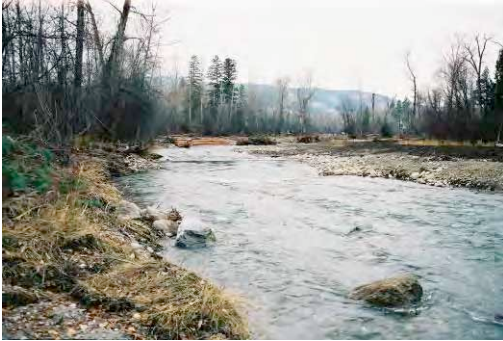
PHOTO MONITORING POINT 18-2004

Photo was taken from left bank at Station 61+00 looking WSW (247.5°). The existing green line along the right bank is located approximately 50 feet from the new right bank and consists of cottonwood, pines and upland shrubs and herbaceous species and knapweed (approx. 100 feet wide). Beyond this is a large unvegetated borrow site. The existing green line along the left bank is located at bankfull and consists of existing vegetation including cottonwoods, pines and wetland and upland shrubs and herbaceous species (50 feet). Community type transitions to open floodplain area dominated by upland herbaceous species and knapweed and then to herbaceous wetlands. No vegetation treatments were implemented in this area in Fall 2004.

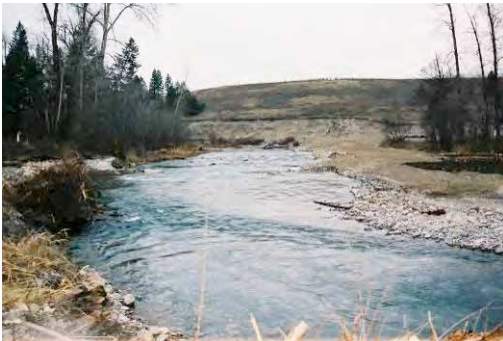
PHOTO MONITORING POINT 19-2004

Photo was taken from left bank at Station 57+50 NNW (337.5°). The existing green line along the right bank is located approximately 20 feet from bankfull and consists of wetland and upland shrubs and herbaceous species and knapweed (approx. 20 feet wide). Beyond this is a large unvegetated borrow site. Existing green line along the left bank is located at bankfull and consists of pines, cottonwoods and upland shrubs (150 feet). Community type transitions to open floodplain area dominated by upland herbaceous species and knapweed. No vegetation treatments were implemented in this area in Fall 2004.

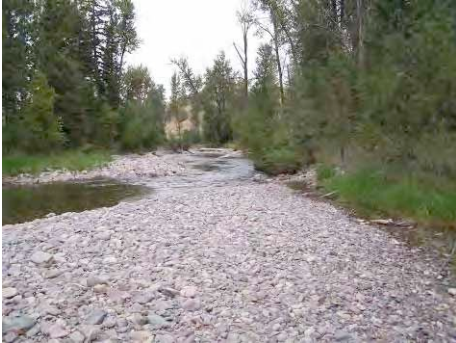
PHOTO MONITORING POINT 1-2005

Photo was taken from right bank looking NNW (337.5°). Location corresponds with Photo point 1-2004. The existing green line along the right bank is located at bankfull and consists of predominantly reed canarygrass and knapweed (approx. 50 feet wide). Community type transitions to cottonwood, pines, and shrub riparian vegetation away from the channel. Downstream green line transitions to shrubs, predominantly alder with an understory of grasses and fireweed and an overstory of pine and cottonwood.

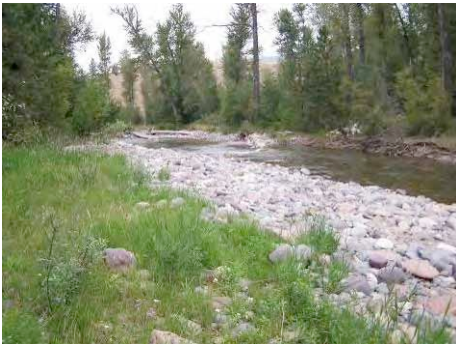
PHOTO MONITORING POINT 2-2005

Photo was taken from left bank looking N (0°). Photo corresponds with photo point 2-2004. The existing green line is at bankfull and dominated by reed canarygrass and sandbar willow regeneration on the left bank. The right bank has eroded with pines fallen into the channel. Away from the channel, the community type transitions to cottonwood, pine, juniper, rose and snowberry. No vegetation treatments were implemented in this area. Structure in channel in photo center is rock cross vane (most upstream structure).

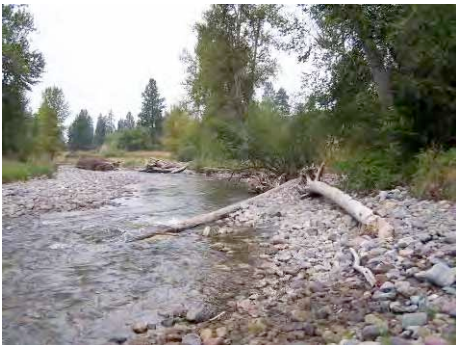
PHOTO MONITORING POINT 3-2005

Photo was taken from right bank looking NW (315°). This photo point does not correspond with a 2004 monitoring point. The existing green line along the right bank is located at bankfull and consists of shrubs including snowberry, red-osier dogwood and wood's rose with a pine and cottonwood with a shrub understory. No vegetation treatments were implemented in this area. Left bank is newly created cobble point bar. Green line is approx. 15 feet from high water mark and consists of existing vegetation-cottonwood and pine with a shrub understory. Herbaceous plugs and native shrubs were planted along left bank. Wood in channel was recruited during the spring 2005 flood event.

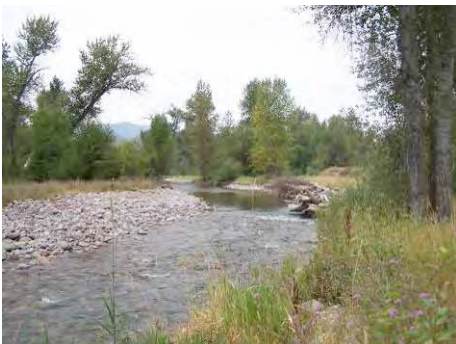
PHOTO MONITORING POINT 4-2005

Photo was taken from right bank looking NW (315°). Photo corresponds with Photo Monitoring Point 3-2004. The existing green line along the right bank is located at bankfull and consists of cottonwood with knapweed and red top in the understory (approx. 10 feet wide). Terrace located to the north and community type transitions to dry upland grasses and invasive species. Green line on left bank is at bankfull and consists of knapweed and grasses. Community type transitions to cottonwood and pine overstory with dry shrubs such as Wood's rose and snowberry in the understory.

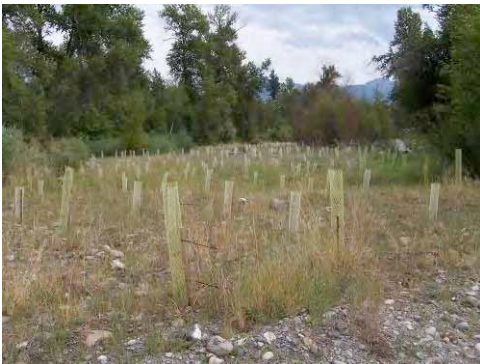
PHOTO MONITORING POINT 26-2005

Photo does not correspond with 2004 monitoring photo. Taken from coir fascine 4 looking SE into plugged channel area. Two survival plots are located here. Vegetation consists of planted herbaceous and shrub species and seeded herbaceous species. Some weedy species present including knapweed and mustard.

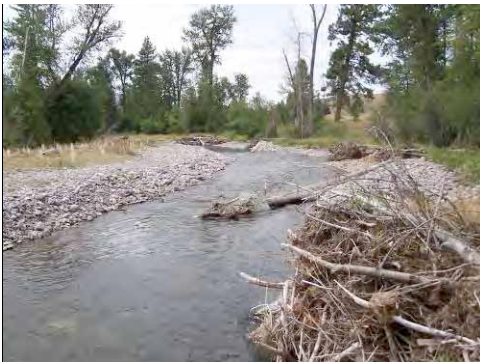
PHOTO MONITORING POINT 27-2005

Photo was taken from right bank looking NW (315°). Photo corresponds with Photo Monitoring Point 16-2004. The existing green line along the right bank consists of transplanted sod placed at downstream end of wetland plug and transitions to pine, cottonwood and wetland and upland shrubs. Green line along the left bank is located at bankfull and consists of seeded grass and forb species. Survival monitoring plot is located here. Community types transitions to pines, cottonwood, upland shrubs and herbaceous species and knapweed for approx. 50 feet and then transitions to open floodplain dominated by upland herbaceous species and knapweed.

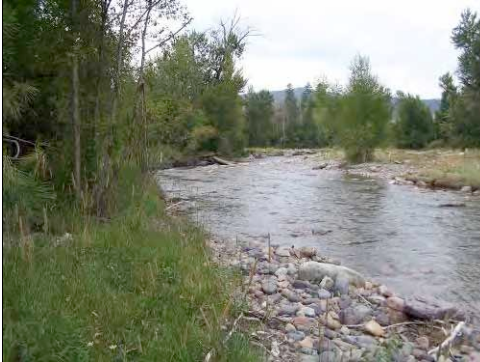
PHOTO MONITORING POINT 29-2005

Photo was taken from left bank looking WSW (247.5°). Right bank green line is located at bankfull and consists of shrubs and cottonwoods. Floodplain was planted with native shrub and herbaceous species. Community type transitions to cottonwood, pines and upland shrubs, herbaceous species and knapweed (approx. 100 feet wide). Beyond this is a large unvegetated borrow site. The existing green line along the left bank is located at bankfull and consists of existing vegetation including cottonwoods, pines and wetland and upland shrubs and herbaceous species (50 feet). Community type transitions to open floodplain area dominated by upland herbaceous species and knapweed and then to herbaceous wetlands.

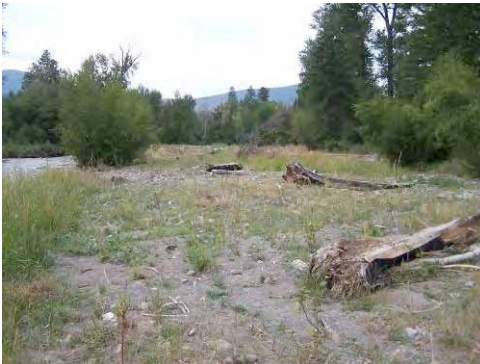
PHOTO MONITORING POINT 30-2005

Photo does not correspond with a 2004 monitoring point. Photo shows sediment deposition in floodplain in constructed floodplain resulting from Spring 2005 flood event.

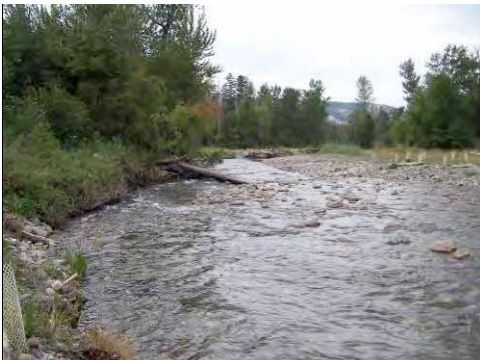
PHOTO MONITORING POINT 31-2005

Photo does not correspond with 2004 monitoring point.

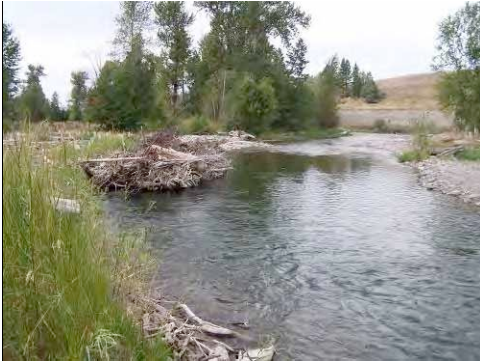
PHOTO MONITORING POINT 32-2005

Photo was taken from left bank at approximately the same location as Photo Monitoring Point 19-2004 looking NNW (337.5°). Soil lift is located lower left hand corner of photo showing growth of seeded grass species.

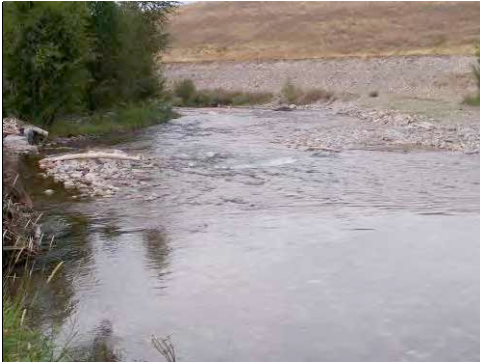
PHOTO MONITORING POINT 33-2005

Photo was taken from left bank looking north (0°). Photo taken from soil lift 11 looking downstream to downstream end of Phase I project reach. The green line on the right bank is located approximately 2 feet above bankfull and consists of wetland shrubs and wetland herbaceous species. The existing green line on the left bank is located approximately 5 feet above bankfull and consists of wetland and upland shrubs and wetland and upland herbaceous species and knapweed.
